## **Modelling of the Oil Spill in M/V LADY TUNA Accident and the Evaluation of the Response Operation in Simulated Condition with PISCES II**

**How to cite:** Aydın, D. & Solmaz, M. S. (2019). Modelling of the Oil Spill in M/V Lady Tuna Accident and the Evaluation of the Response Operation in Simulated Condition with PISCES II. *International Journal of Environment and Geoinformatics (IJEGEO)*, Vol. 6(2): 213-224, DOI: 10.30897/jegeo.579066

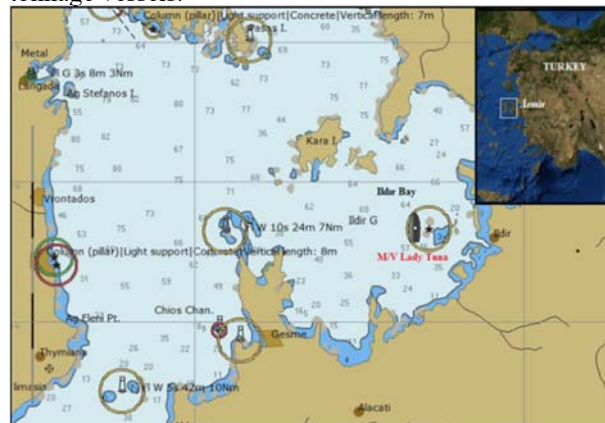
Gulf of Ildır is located between Karaburun Peninsula and Çeşme Canal in the west of Turkey. North coastal strip of Ildır Gulf is very narrow and shows a sudden deepening structure (Meriç et al., 2012). The accident happened near Fener Island in the Ildır Bay district of Çeşme province of İzmir (Lat: 38° 23.26' N - Long: 026° 25.42' E) is shown in Fig. 5.

Figure 5. Position of the Accident (CPN, 2018).

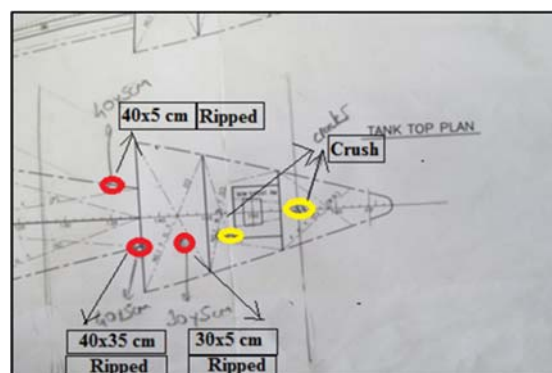
After the accident, the master of the ship informed to the agency about the oil pollution and reported that response operation was necessary urgently. There was no attempt by the ship to prevent oil pollution. After the soundings were taken from the tanks by the crew, it was determined that there were damages to fore-peak tank, No.1 center ballast tank, No.1 center fuel tank, No.2 port and starboard fuel tanks. There was leakage from the fuel tanks to the sea. Damaged parts of the ship on the Transverse Plan are shown in Fig. 6. (AIB, 2017)

Figure 6. Damaged Parts of the Ship (AIB, 2017).

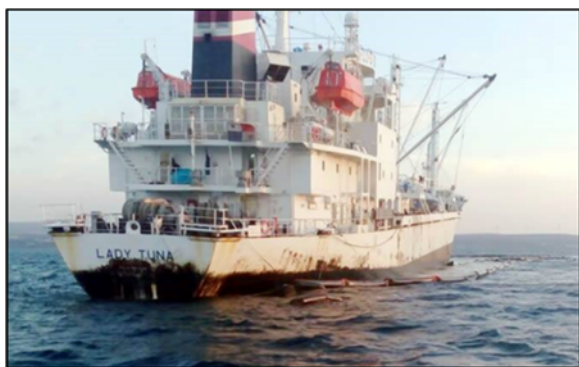
However, according to the captain's statement, the time of the accident was recorded in the ship's logbook at 13:30 LT. The insufficient boom was encircled to the ship at 00:30 LT on 19 December 2016 (11 h later) to control the pollution arising from the ship. Because of the bad weather condition, the second barrier was encircled 20 h after the spillage. (Sunlu, Kayacan and Küçükgül, 2017)

Figure 7. Containment of Spilled Oil by Barriers (www.seanews.com.tr, 2017).

- The response company reached the accident region 7h after the accident, but firstly they began to encircle the fish farms with barriers. About 9 h after the spillage, they began to encircle the ship around with a barrier (which is not efficient in high sea condition). However, first of all, they should have started the response operation against the leak source. As a

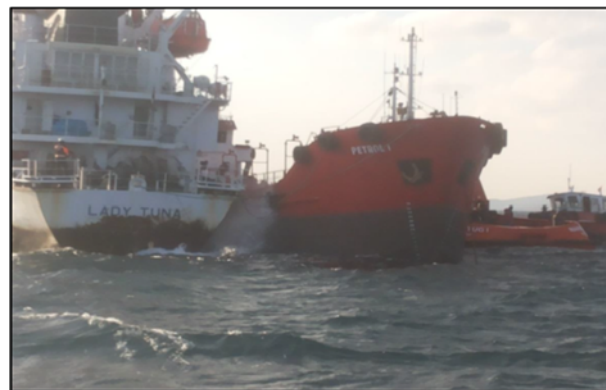
On 24th December 2016 (6 days after the accident), tanker ship Petrol-1 (Fig. 9) came alongside M/V Lady Tuna in order to discharge the fuel in her damaged parts. The discharging operation was completed on 26th December 2016 (8 days after the accident). Salvage operations were started at 09:00 LT on 27th December 2016, 9 days after the accident. (AIB, 2017)

Figure 9. Transfer Operation (AIB, 2017).

- On 24th December 2016 (6 days after the accident), the tanker ship discharged the fuel in her damaged tanks and discharging operation was completed on 26th December 2016. The weather report shows that the violent storm increased three days after the accident. It created a greater danger to the damaged ship and the environment. The discharge operation of the fuel on the ship normally should be made shortly after the accident.

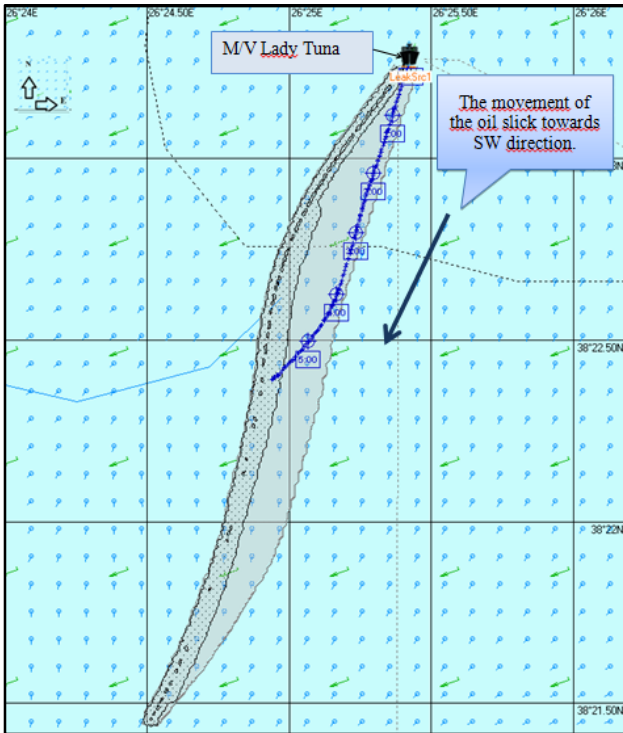
the accident was towards SW direction which drifts in response to the wind and the current (Fig. 13). The pollution and spillage parameters after 6 h from the accident are presented in Table 4.

Figure 13. Movement Direction of the Oil Slick (Δt: 6 h).

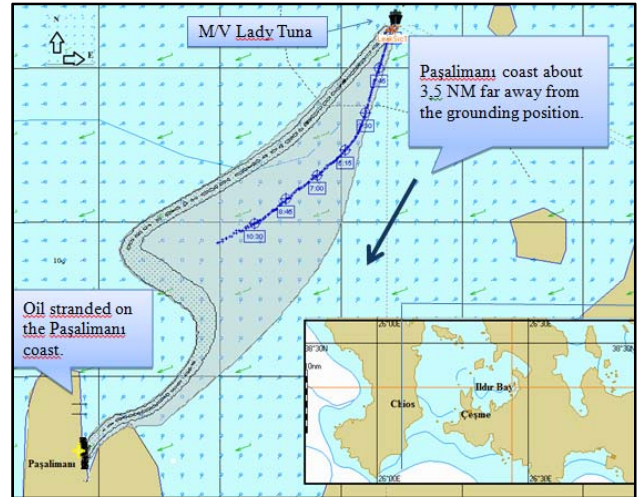
The area shown in gray color indicates the area where oil is spreading for up to 12 h from the beginning of the scenario (spilled oil; 60 tons) (Fig. 14). The program shows the information “Oil impact on land” on the window screen. The oil reached on the Paşalimanı coast (0,02 %) about 12 h later following the spillage (Table 5).

Figure 14. Scenario-1: The Oil Stranded on the Paşalimanı Coast (Δt: 12 h).

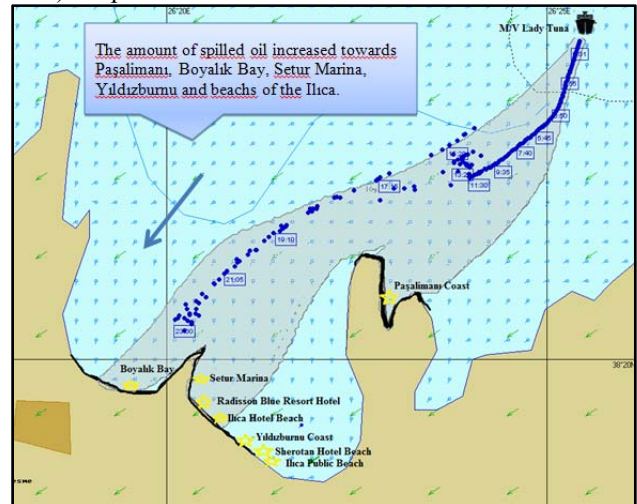
As a result of the scenario, the movement direction of the oil slick after 36 h from the accident is shown in Fig. 15. It is clearly seen that the oil was stranded at Paşalimanı coast, the Boyalık Bay, the Setur Çeşme Marina, the Radisson Blue Resort Hotel beach, the Ilıca Hotel beach, the Yıldızburnu coast, Sherotan Hotel beach and the Ilıca public beaches. The pollution and spill parameters (after 36 h) are presented in Table 6.

Figure 15. Scenario-1: The Movement direction of the oil slick (Δt: 36 h).

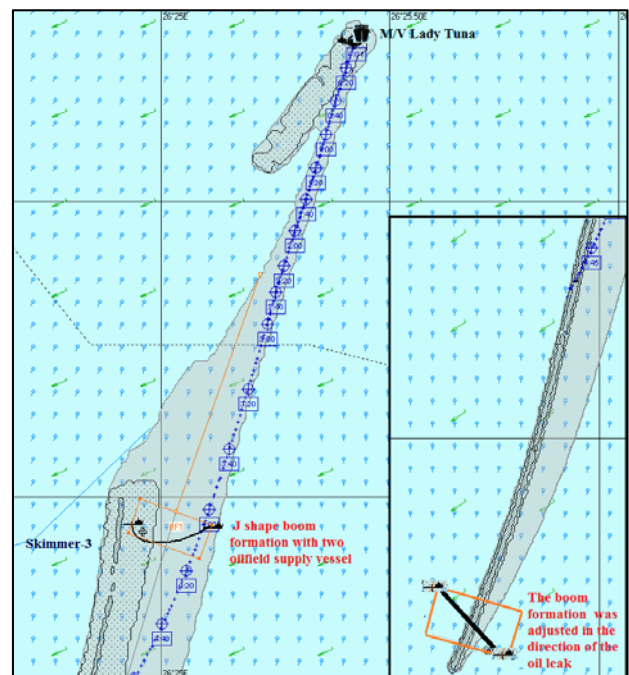
The one J shape Boom Formation-2 was placed on the scene with the Oleophilic Skimmer-3 and two Oilfield supply vessels as a single unit at 15:40 UTC (5 h after the spillage). Movement of the J shape Boom Formation-2 was controlled by two Oilfield supply vessels and it allowed the oil collecting by trawling (Fig. 17). J shape Boom Formation-2 (300 m open water boom) was adjusted in the direction of the oil leak and moved with an Oleophilic skimmer towards the leakage source. The Response Operation with Oil Containment Boom Formation-1 and J Shape Boom Formation-2 were presented in Fig. 18.

Figure 17. The Movement of the J Shape Boom Formation-2 with the Skimmer-3.

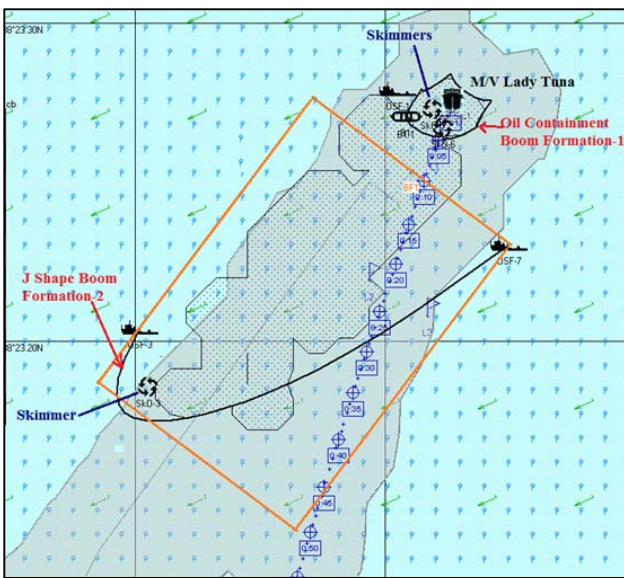
Figure 18. The Response Operation with Oil Containment Boom Formation-1 and J Shape Boom Formation-2.

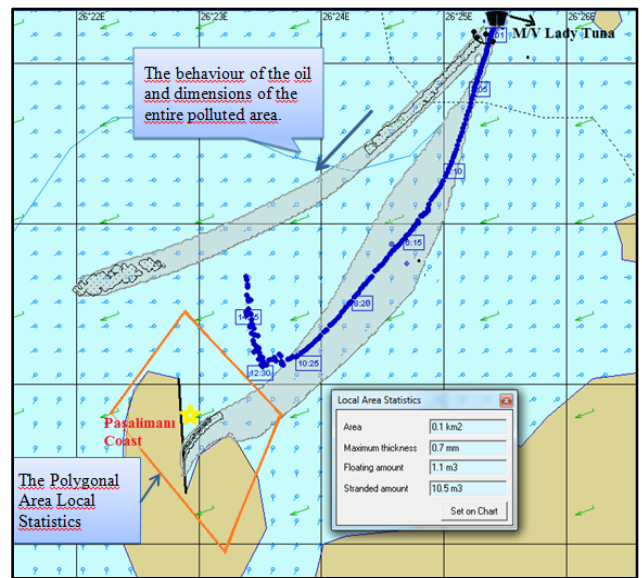
Figure 19. The Behavior of the Spilled Oil and Local Area Statistics ( $\Delta t$ : 15 h).

The display of oil pollution in gray color indicates the size of the entire polluted area from the start of the scenario until 15 h following the spillage. After using the resources of response on the sea, it is observed that the direction of oil has changed.
