**INCREASING OPERATIONAL EFFICIENCY OF HIGH SPEED RO-RO VESSELS
VIA NEW HULL COATING TECHNOLOGIES**

**M.Sc., Maritime Transportation and Management Engineering, Piri Reis University
2017**

**Submitted to the Institute for Graduate Studies in
Science and Engineering in partial fulfillment of
the requirements for the degree of Master of Science**

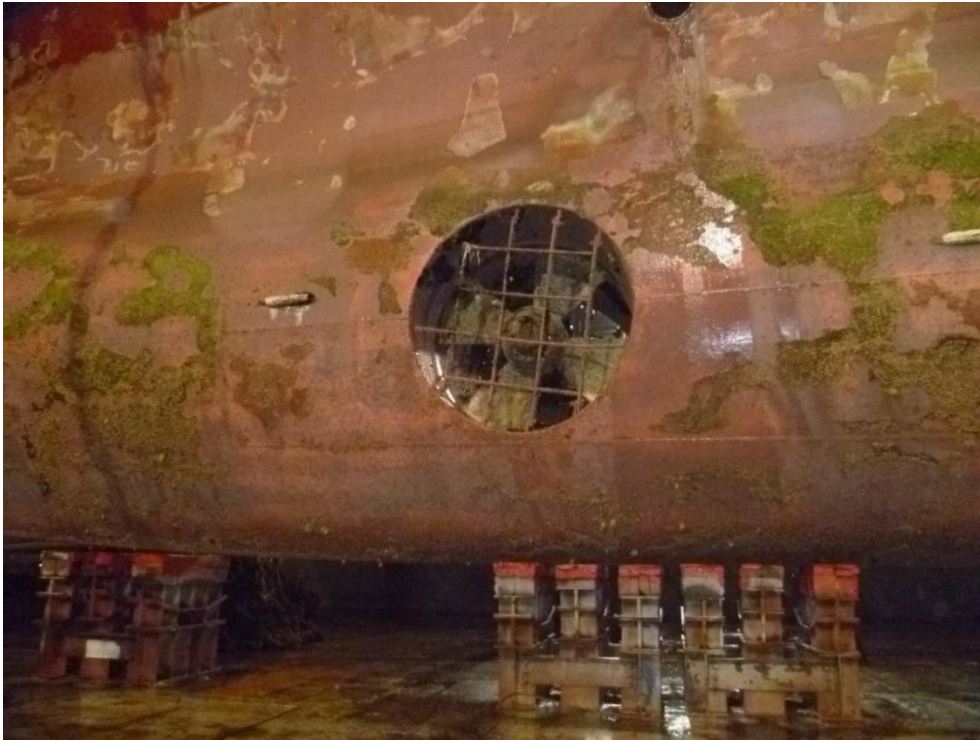
Figure 4.1. VESSEL 1, 2013 Dry-dock, photo of hull condition, after first wash, condition before 1st type foul release coating application

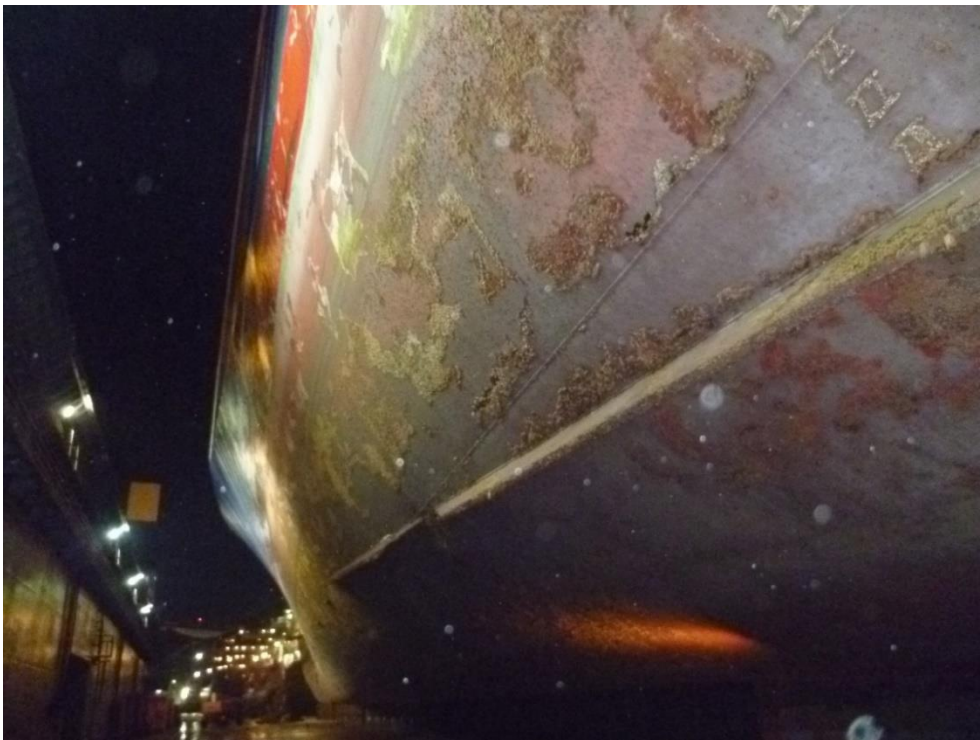
Figure 4.2. VESSEL 1, 2013 Dry-dock, photo of hull condition, after first wash, condition before 1st type foul release coating application

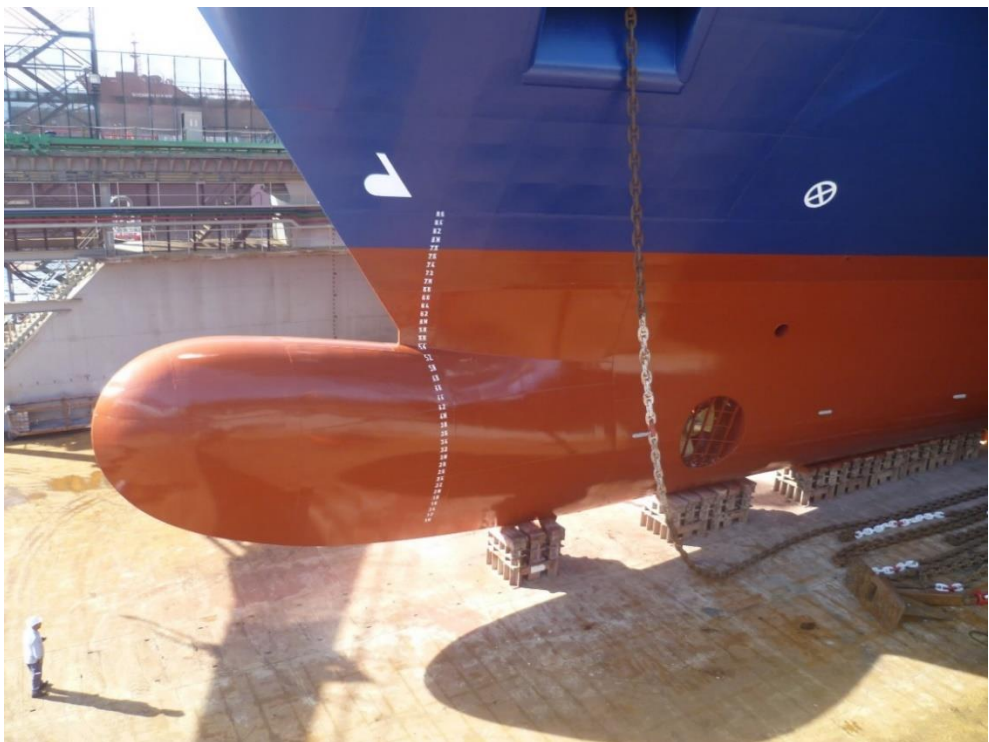
Figure 4.4. VESSEL 1, 2013 Dry-dock, photo of hull condition, condition after 1st type foul release coating application

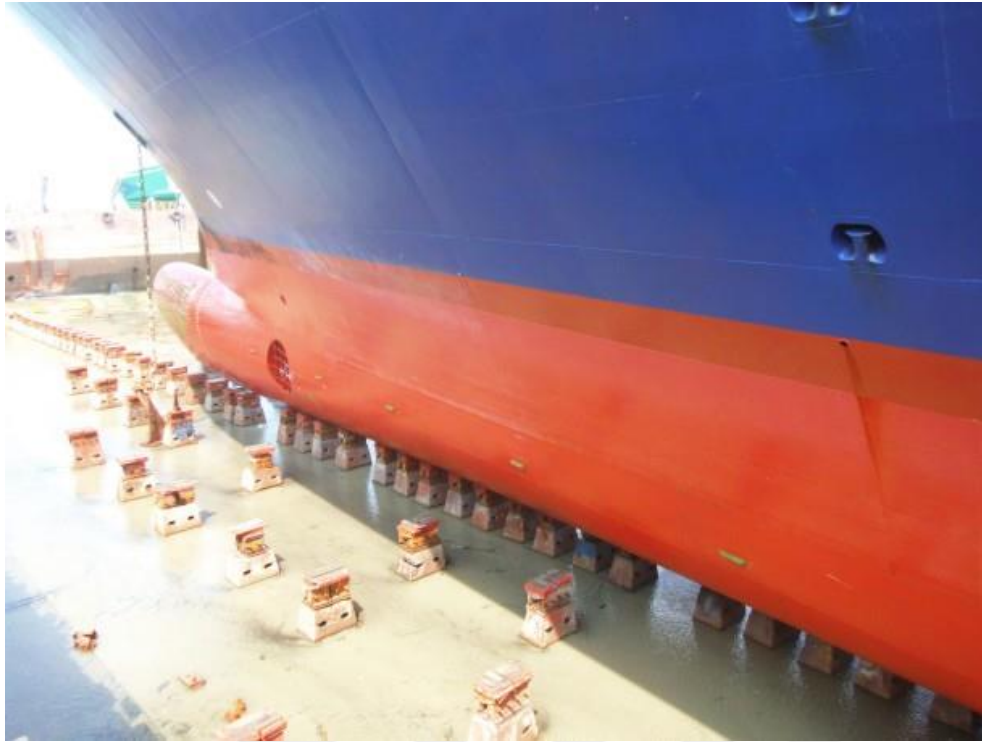
Figure 4.5. VESSEL 1, 2016 Dry-dock, photo of hull condition, just after entering the dry-dock

Vessel 1 dry-docked again in 2016, hull and coating condition checked visually, hull was clean and coating condition was very good. Only few slimes observed on vertical side with a 0,5-meter width on the loaded draft area where is open to sunshine. Flat bottom was completely clean and no slime were observed. Representing photos given in figures 4.5 and 4.6. Just one layer of 1st type of foul release coating technology applied again to observe performance of vessel for next 5 years. It was used to dry-dock the vessel every 2,5 year. With the performance of 1st type foul release coating technology, company decided to dry-dock the vessel every 5 years.

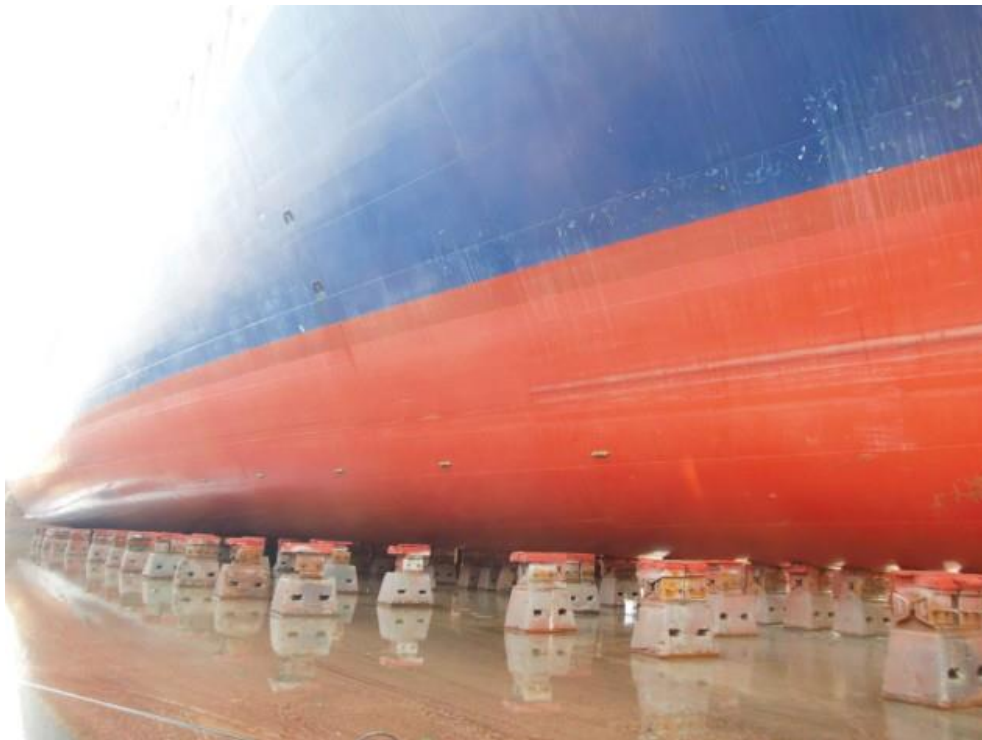
Figure 4.6. VESSEL 1, 2016 Dry-dock, photo of hull condition, condition just after entering the dry-dock

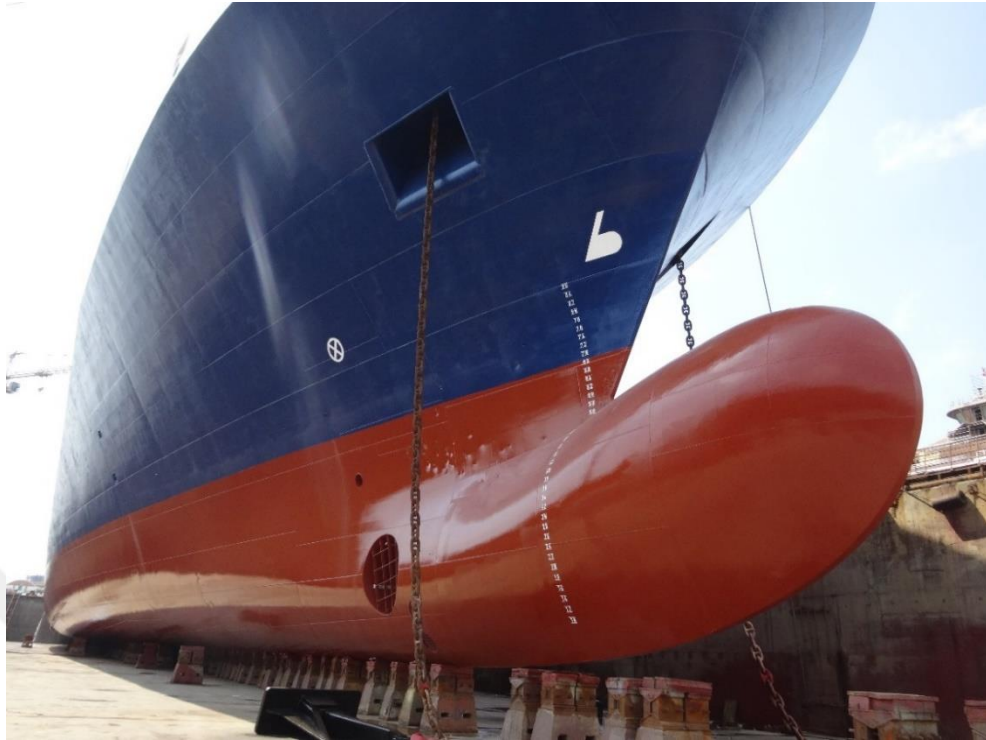
Figure 4.7. VESSEL 1, 2016 Dry-dock, photo of hull condition, condition after 1 layer of 1st type foul release coating application

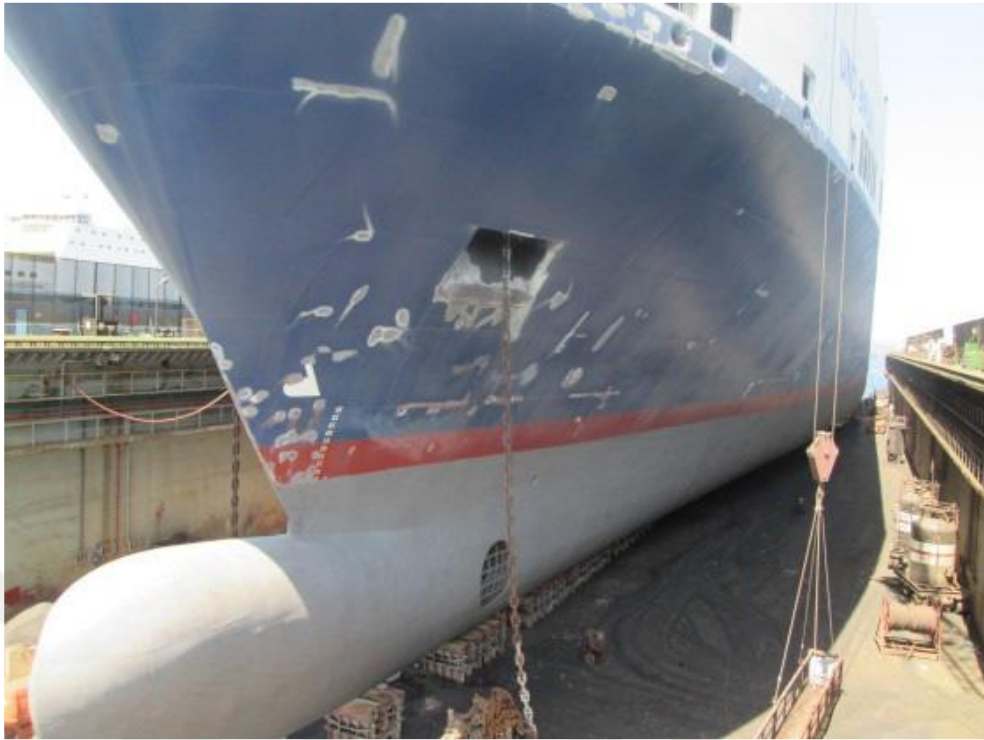
Figure 4.12. VESSEL 2, 2014 Dry-dock, photo of hull condition, after full blasting, condition before 1st type foul release coating application

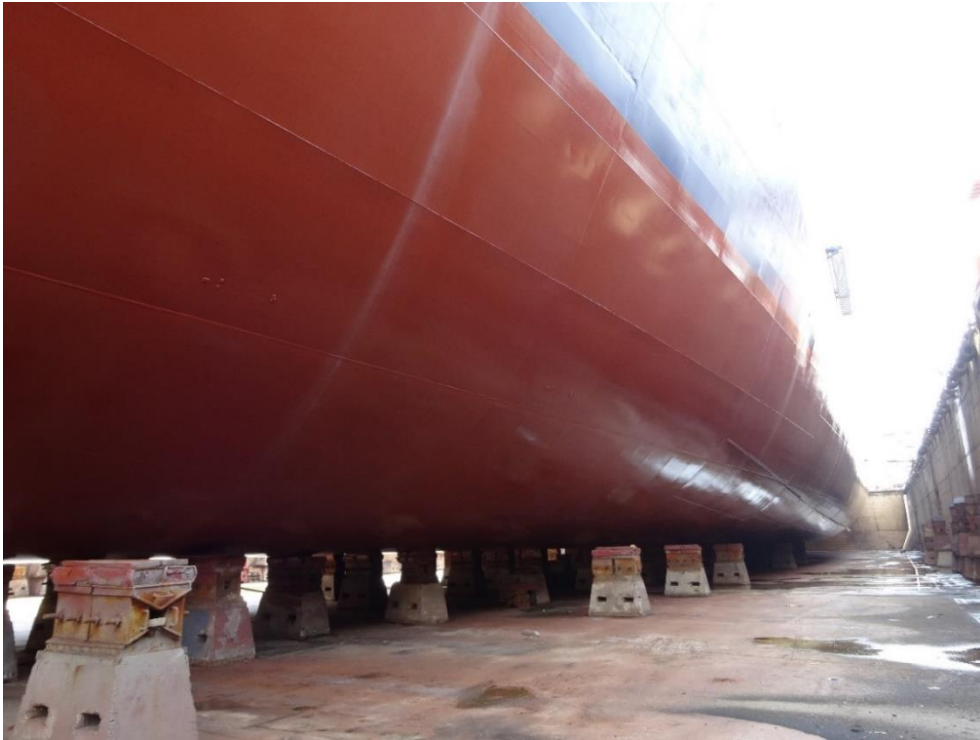
Figure 4.14. VESSEL 2, 2014 Dry-dock, photo of hull condition, condition after 1st type foul release coating application

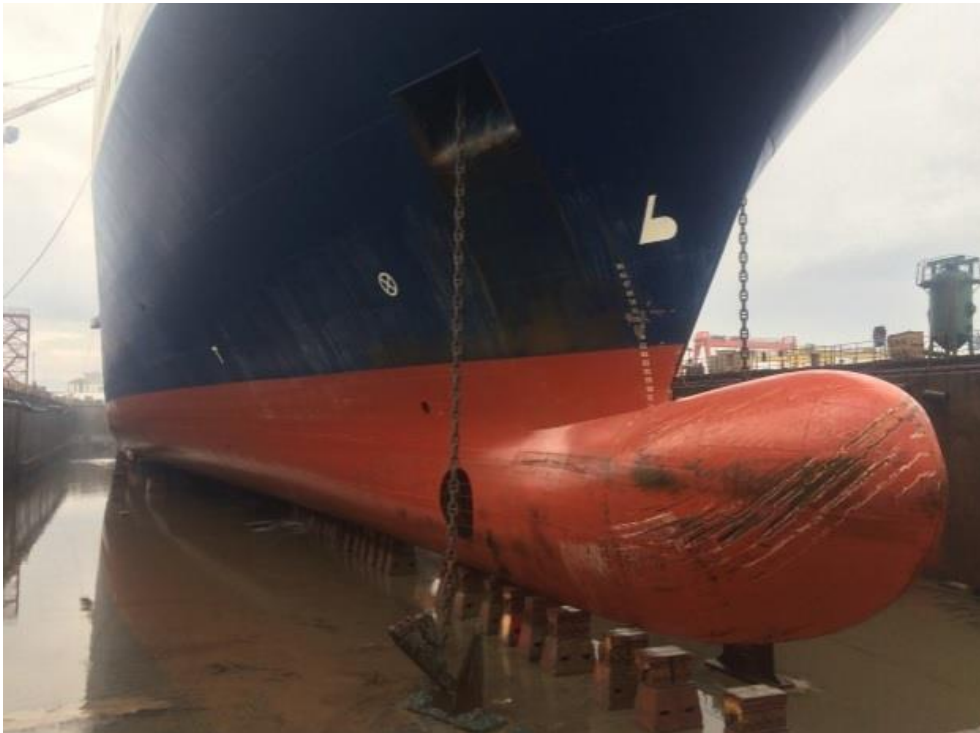
Figure 4.15. VESSEL 2, 2017 Dry-dock, photo of hull condition, condition just after entering the dry-dock

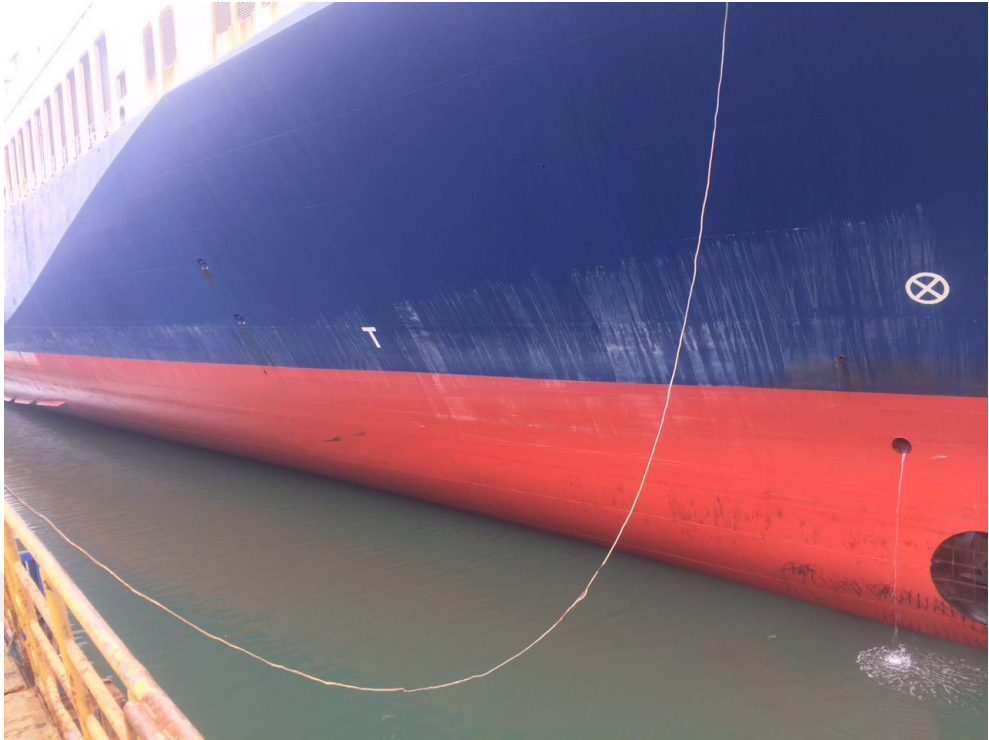
Figure 4.16. VESSEL 2, 2017 Dry-dock, photo of hull condition, condition just after entering the dry-dock

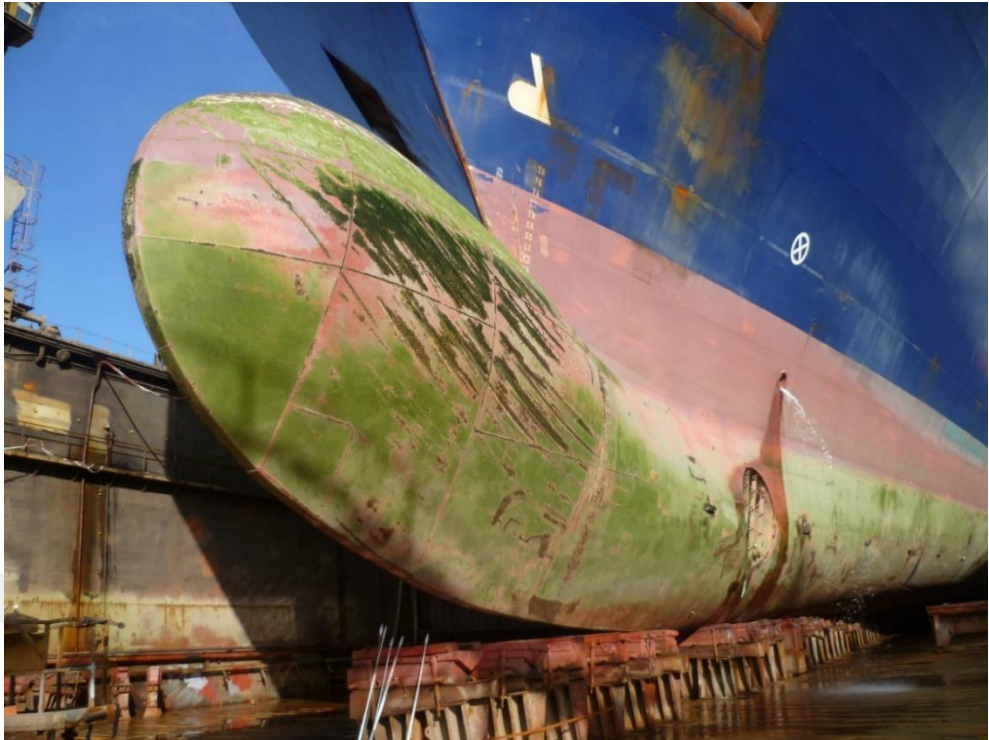
Figure 4.19. VESSEL 3, 2013 Dry-dock, photo of hull condition, just after entering the Dry-dock

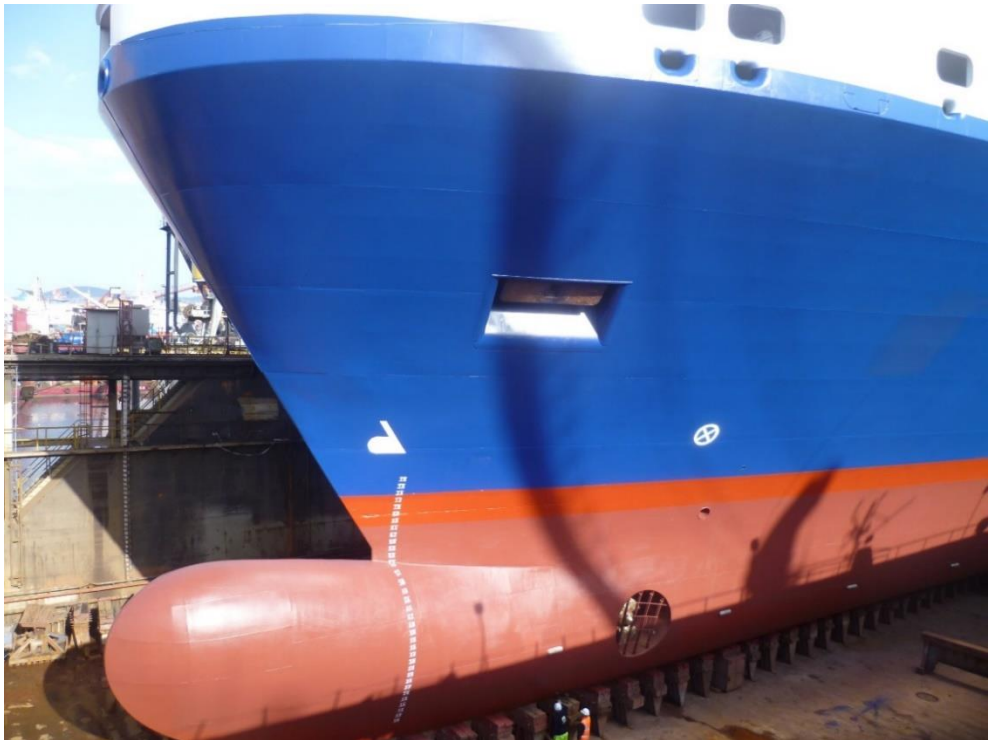
Figure 4.20. VESSEL 3, 2013 Dry-dock, photo of hull condition, condition after 1st type self- polishing coating application with only %25 blasting

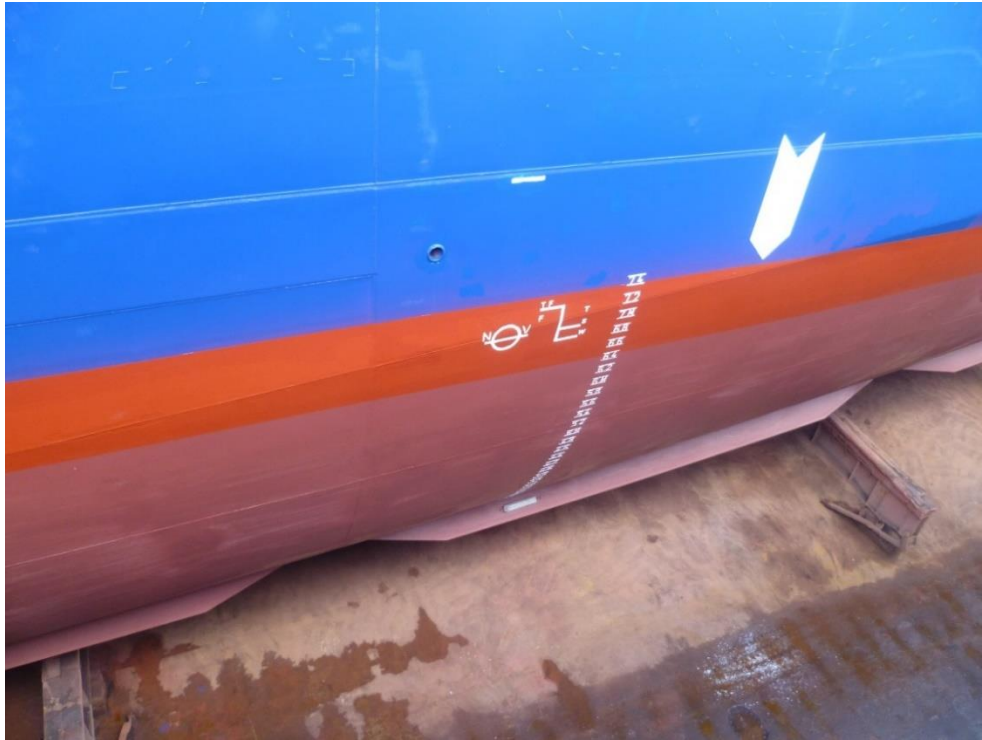
Figure 4.21. VESSEL 3, 2013 Dry-dock, photo of hull condition, condition after 1st type self-polishing coating application with only %25 blasting

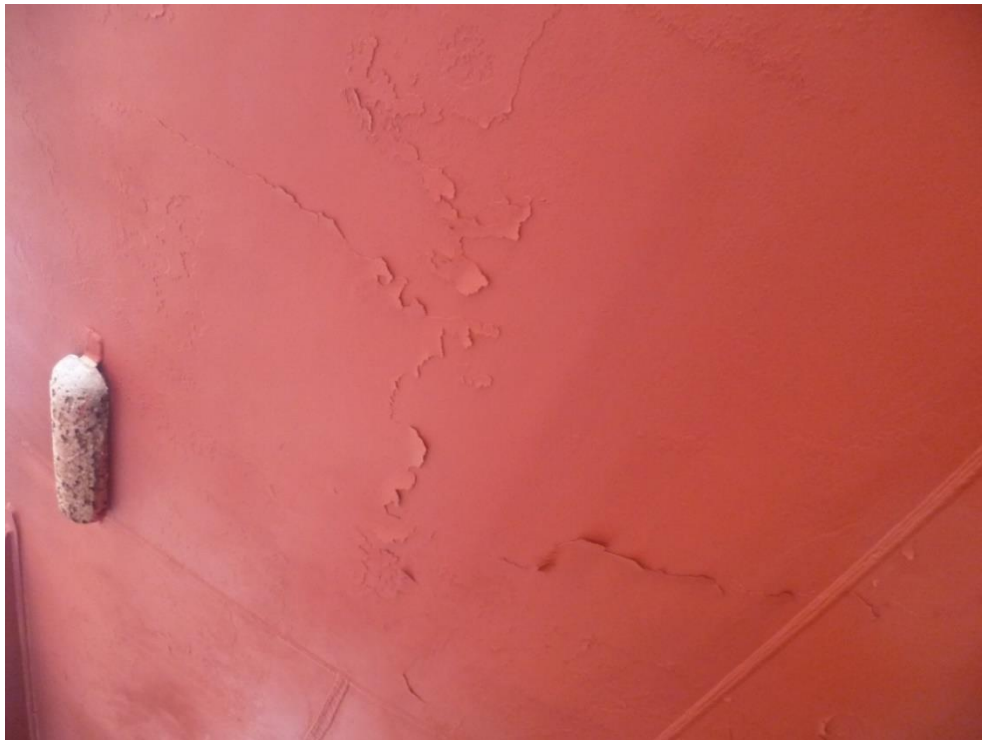
Figure 4.22. VESSEL 3, 2013 Dry-dock, photo of hull condition, condition after 1st type self- polishing coating application with only %25 blasting

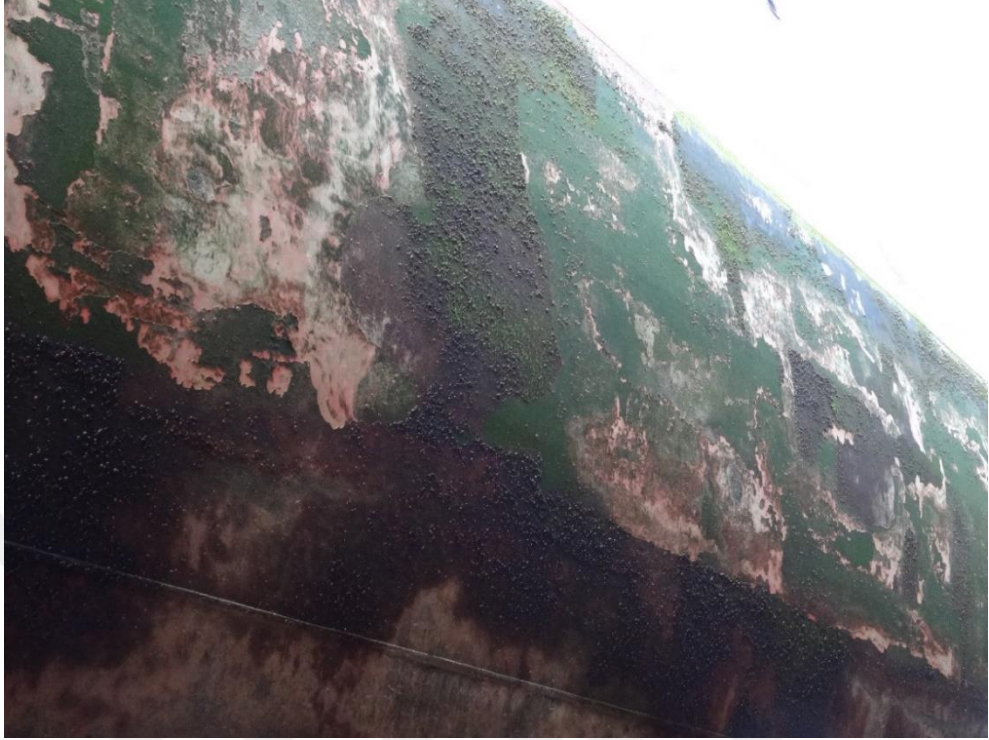
Figure 4.23. VESSEL 3, 2015 Dry-dock, photo of hull condition, just after entering the Dry-dock

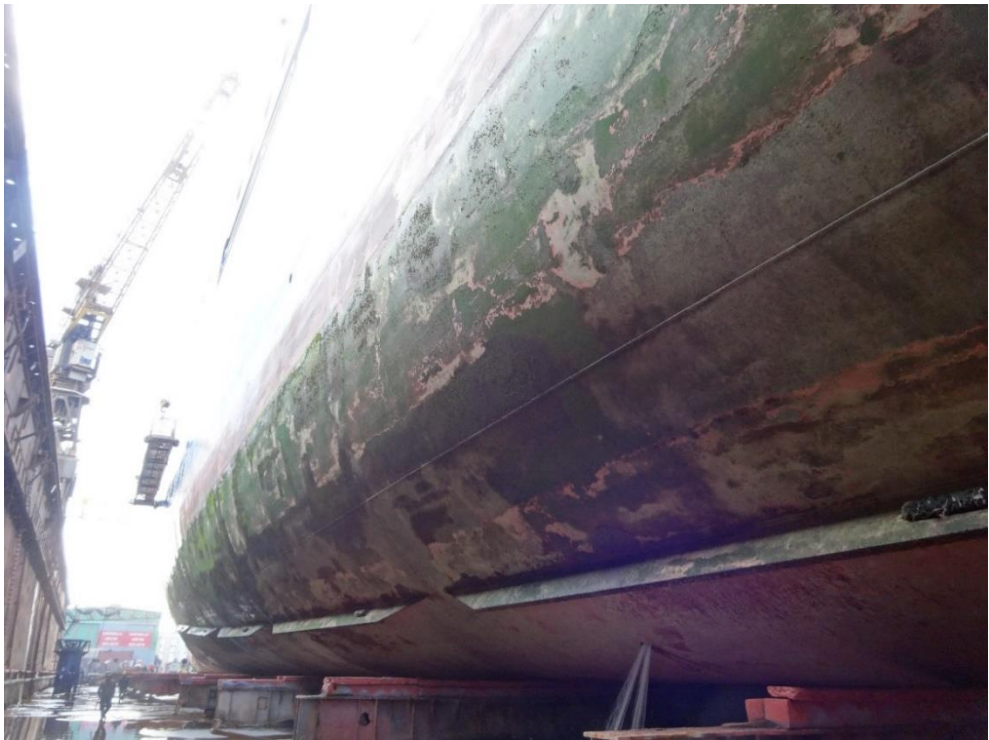
Figure 4.24. VESSEL 3, 2015 Dry-dock, photo of hull condition, just after entering the Dry-dock

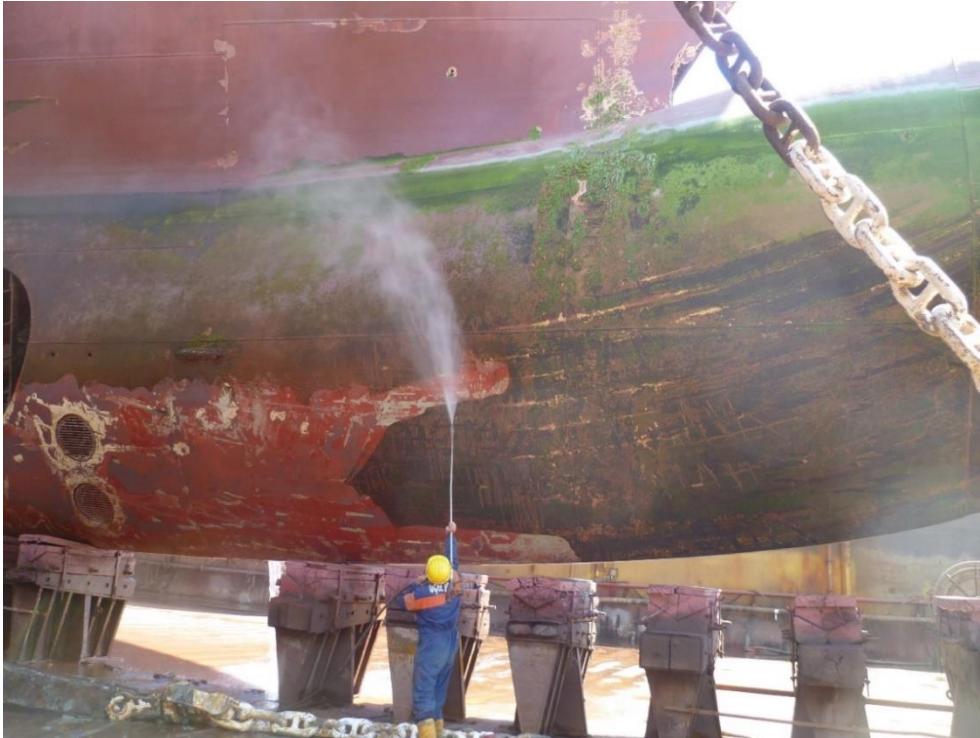
Figure 4.28. VESSEL 4, 2013 Dry-dock, photo of hull condition, condition during first wash with fresh water

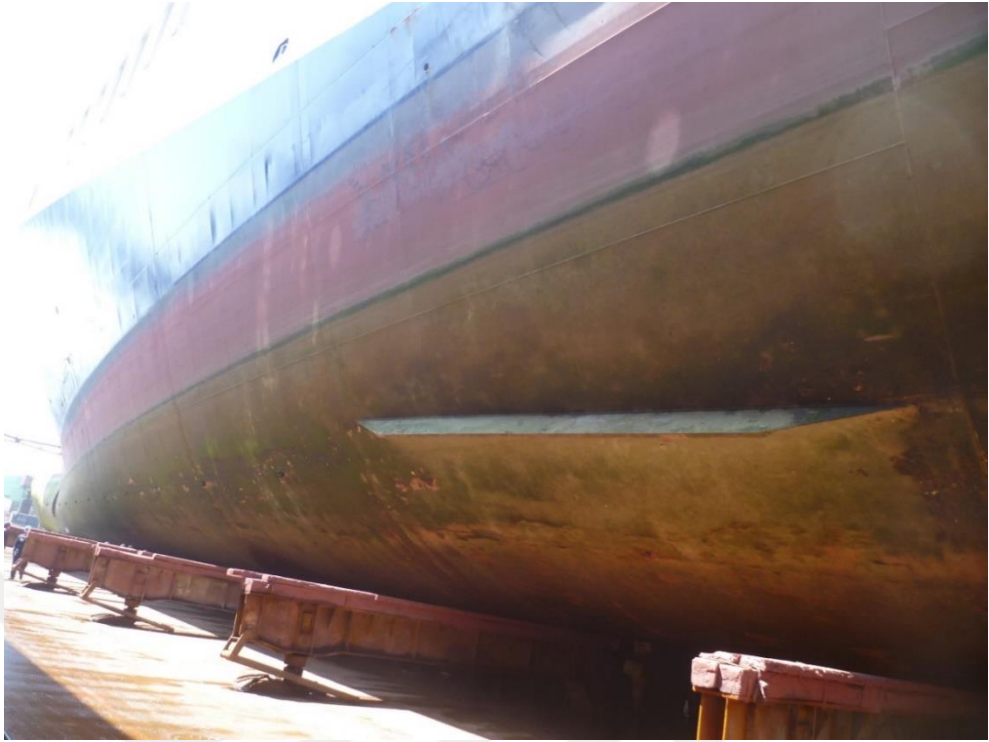
Figure 4.29. VESSEL 4, 2013 Dry-dock, photo of hull condition, condition just after entering the dry-dock

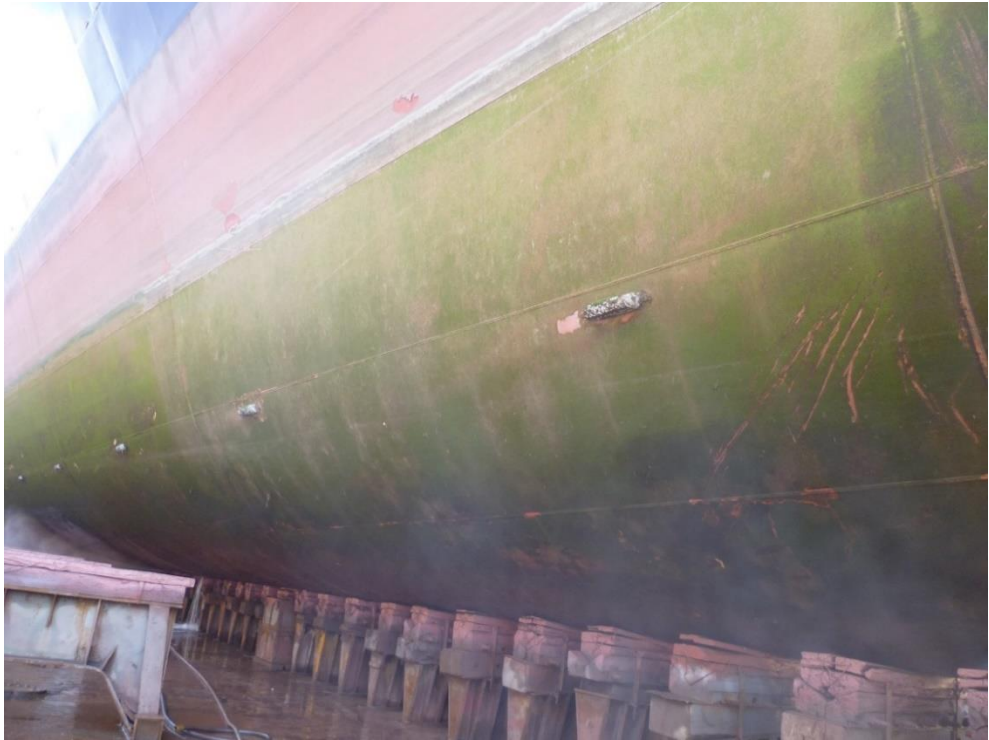
Figure 4.30. VESSEL 4, 2013 Dry-dock, photo of hull condition, condition just after entering the dry-dock

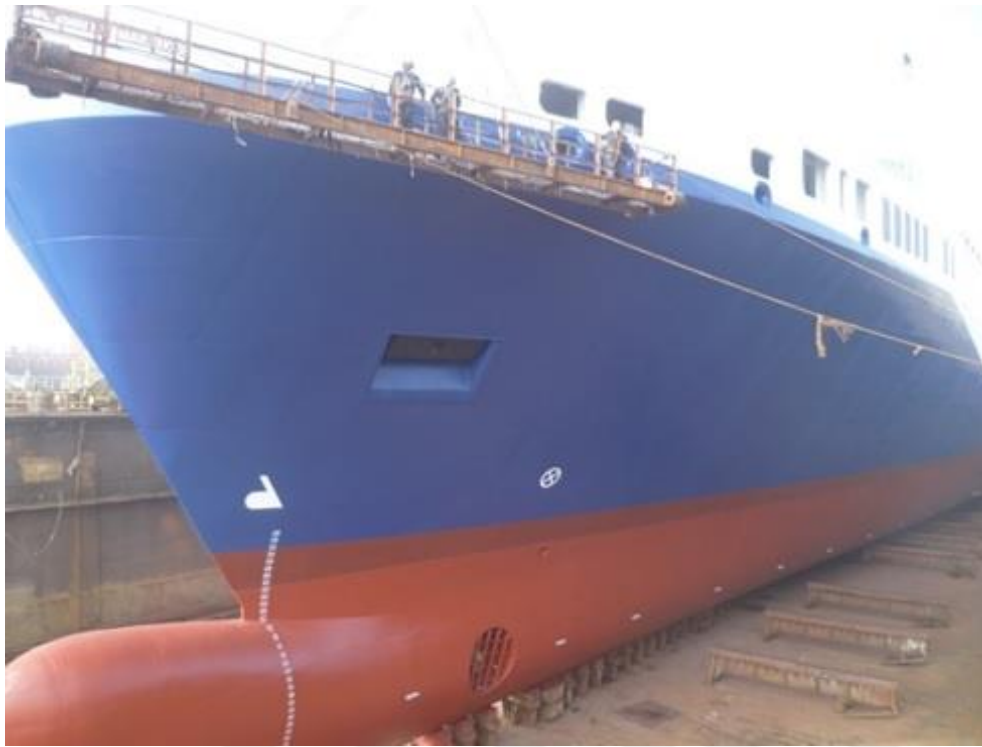
Figure 4.31. VESSEL 4, 2013 Dry-dock, photo of hull condition, condition after full blasting + 2nd type self-polishing coating application

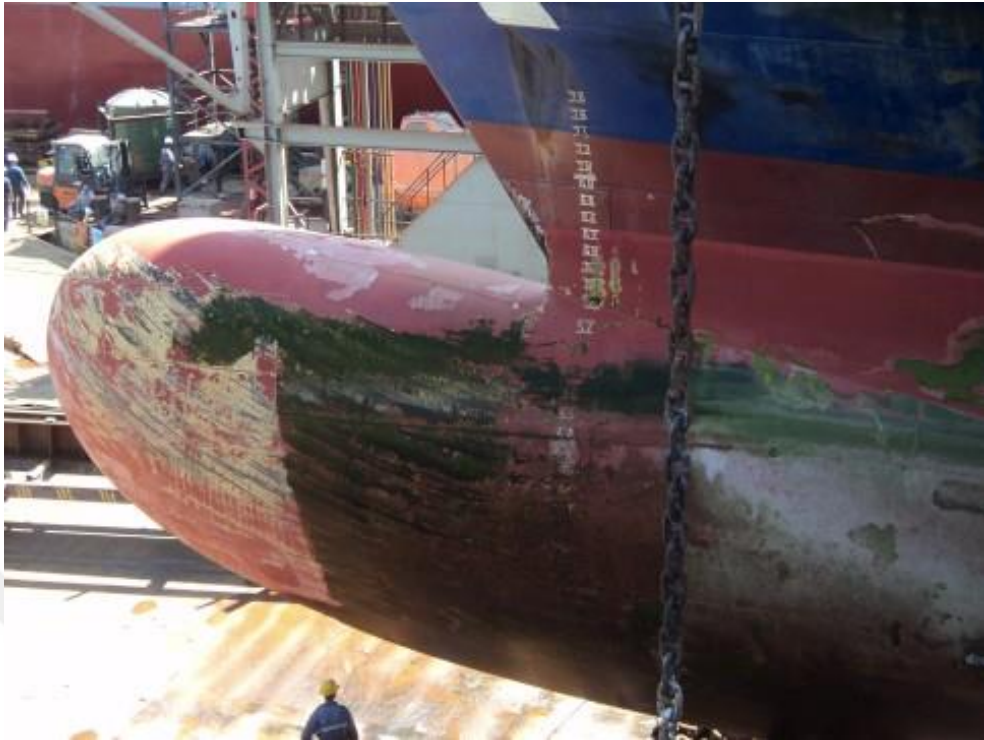
Figure 4.33. VESSEL 4, 2015 Dry-dock, photo of hull condition, during high pressure wash

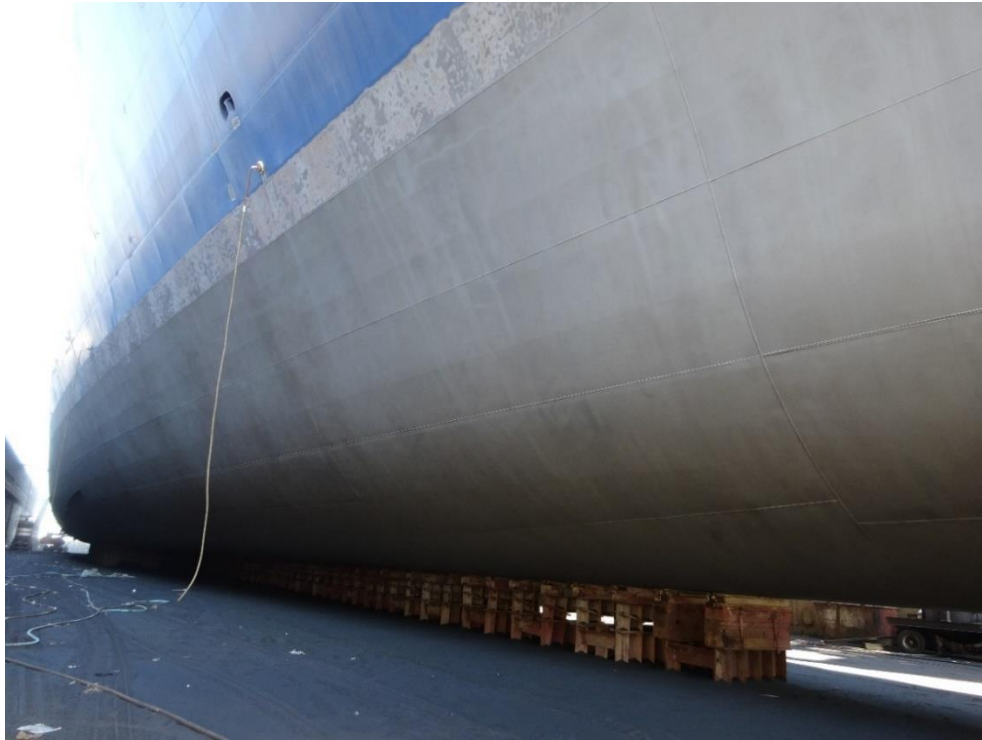
Figure 4.35. VESSEL 4, 2015 Dry-dock, photo of hull condition, full blasting completed

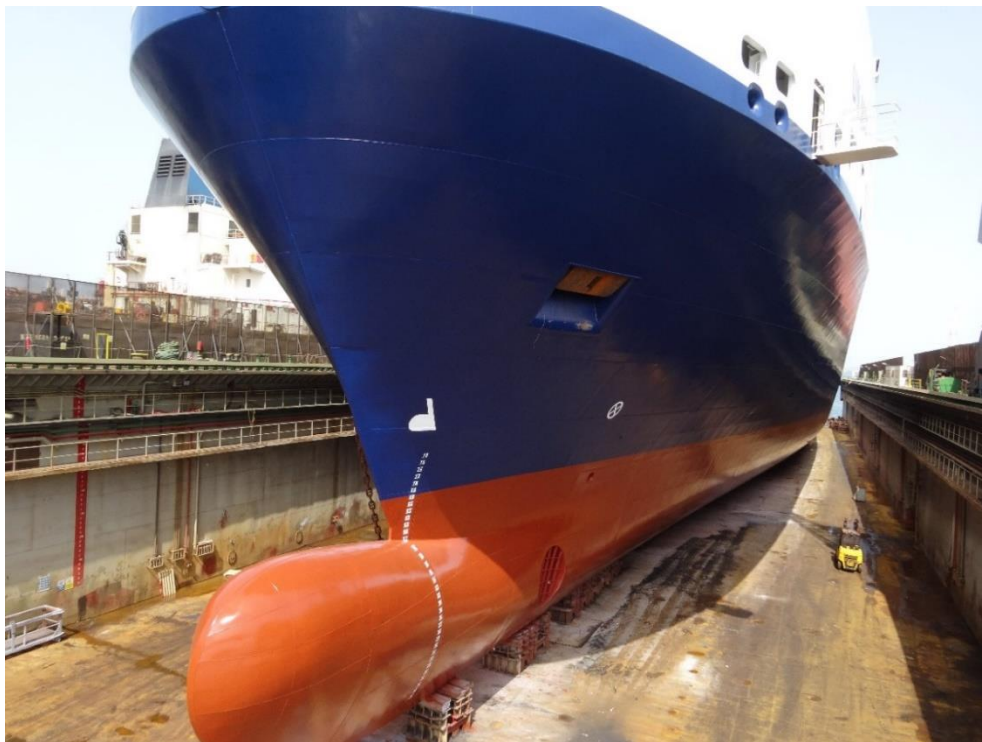
Figure 4.36. VESSEL 4, 2015 Dry-dock, photo of hull condition, after 1st type foul release coating application

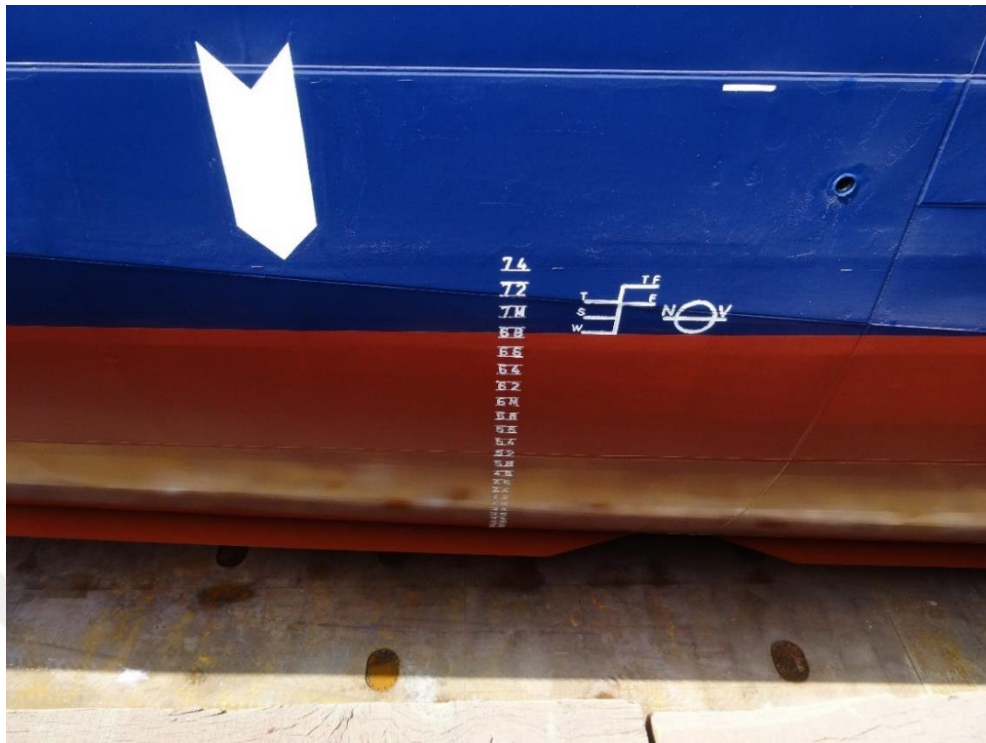
Figure 4.37. VESSEL 4, 2015 Dry-dock, photo of hull condition, after 1st type foul release coating application

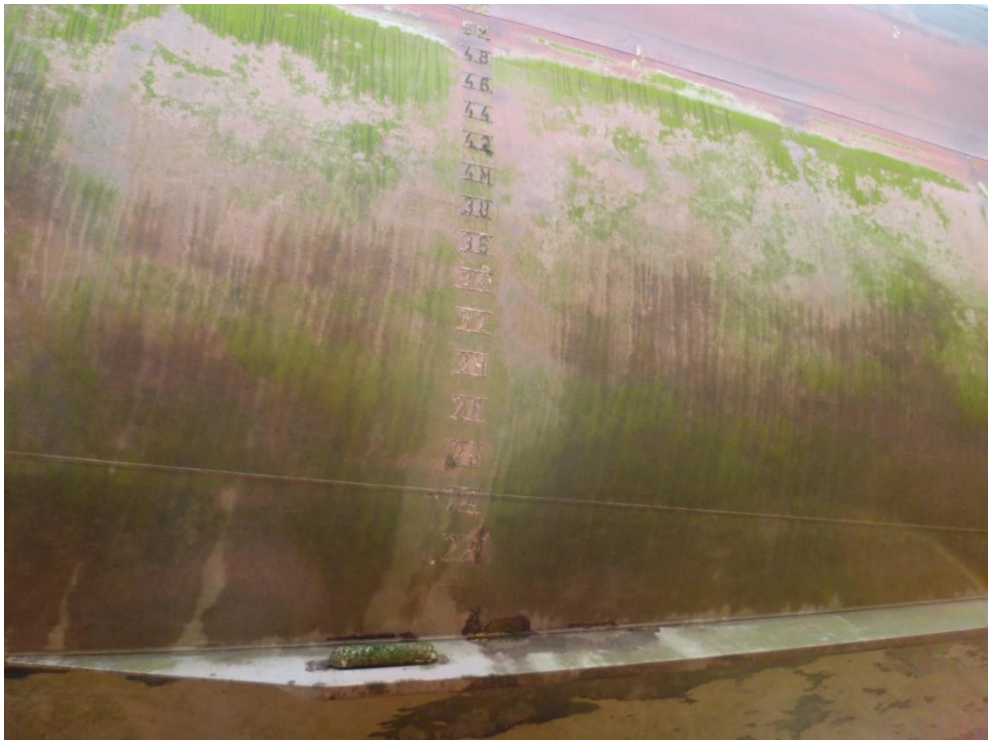
Figure 4.39. VESSEL 5, 2013 Dry-dock, photo of hull condition, just after entering the dry-dock

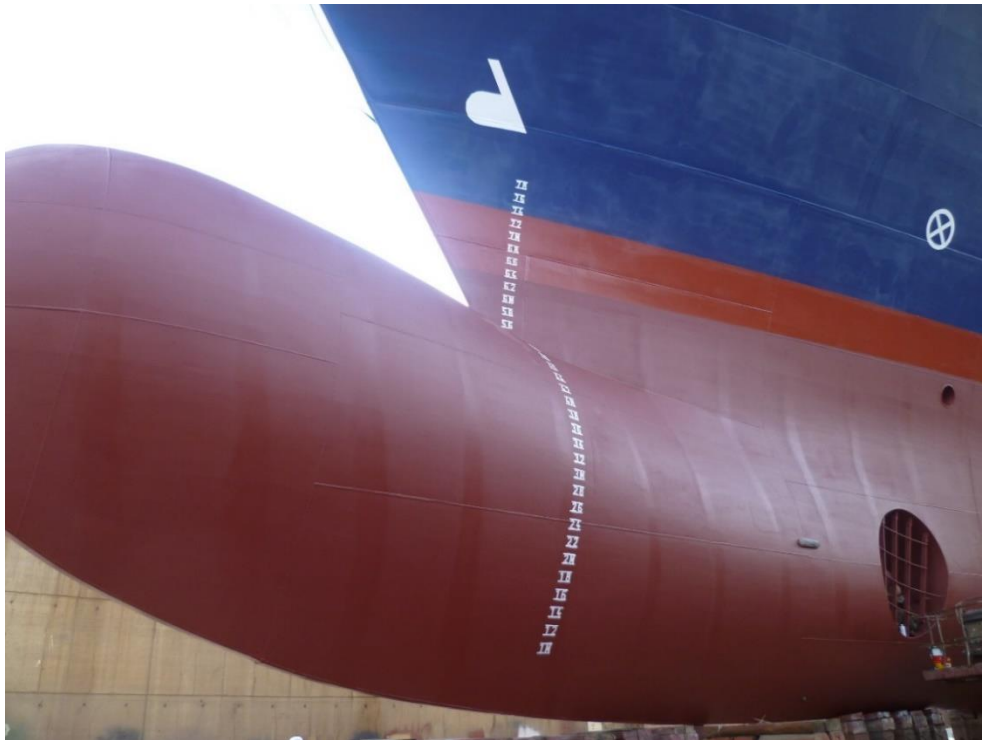
Figure 4.41. VESSEL 5, 2013 Dry-dock, photo of hull condition, after application of 3rd type self-polishing coating

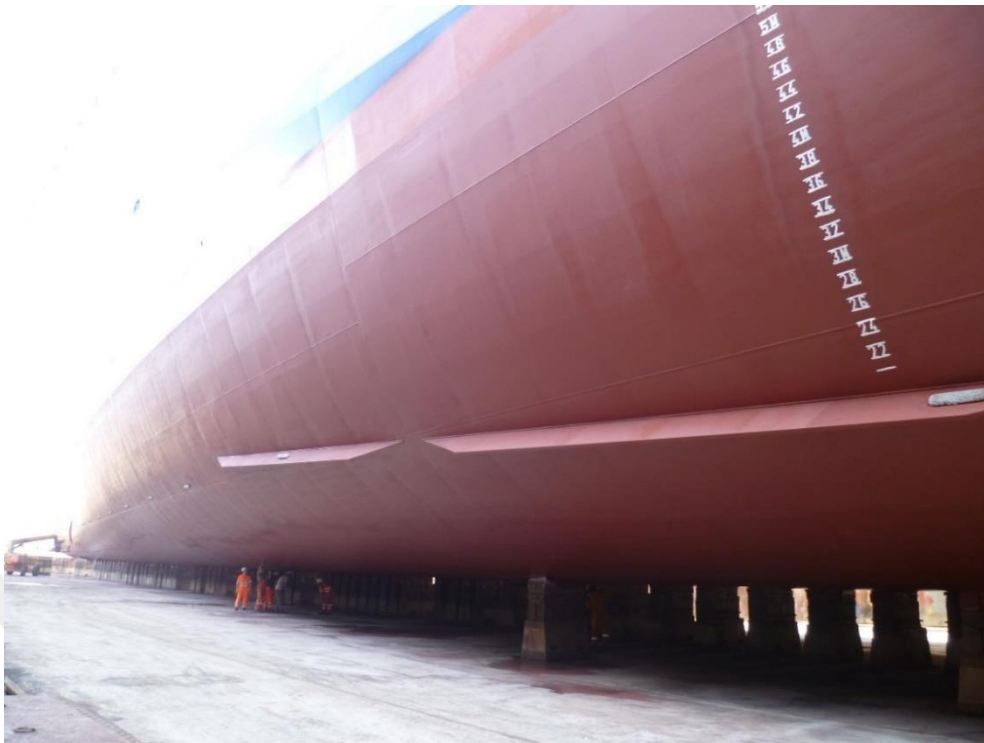
Figure 4.42. VESSEL 5, 2013 Dry-dock, photo of hull condition, after application of 3rd self-polishing coating

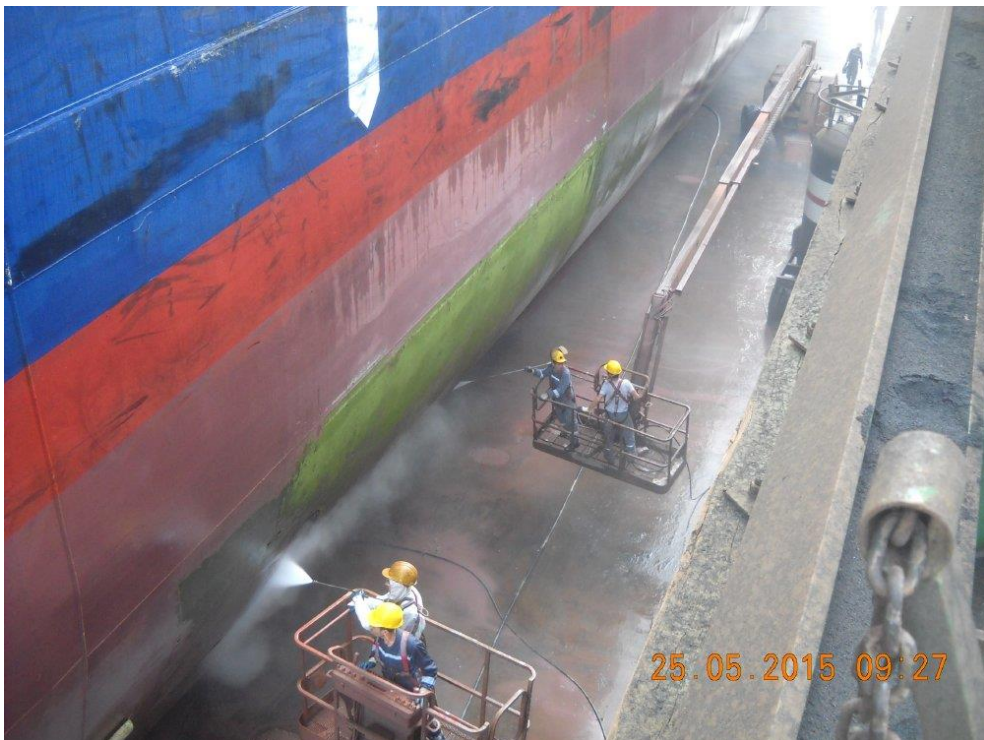
Figure 4.43. VESSEL 5, 2015 Dry-dock, photo of hull condition, during high pressure water washing

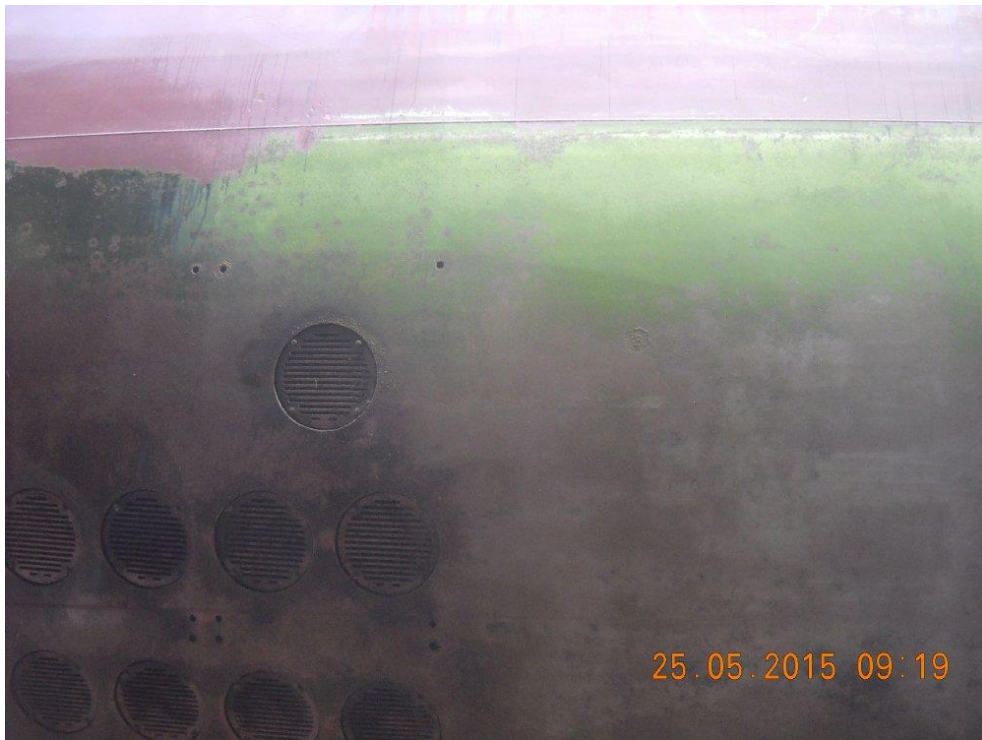
Figure 4.44. VESSEL 5, 2015 Dry-dock, photo of hull condition, before high pressure water wash

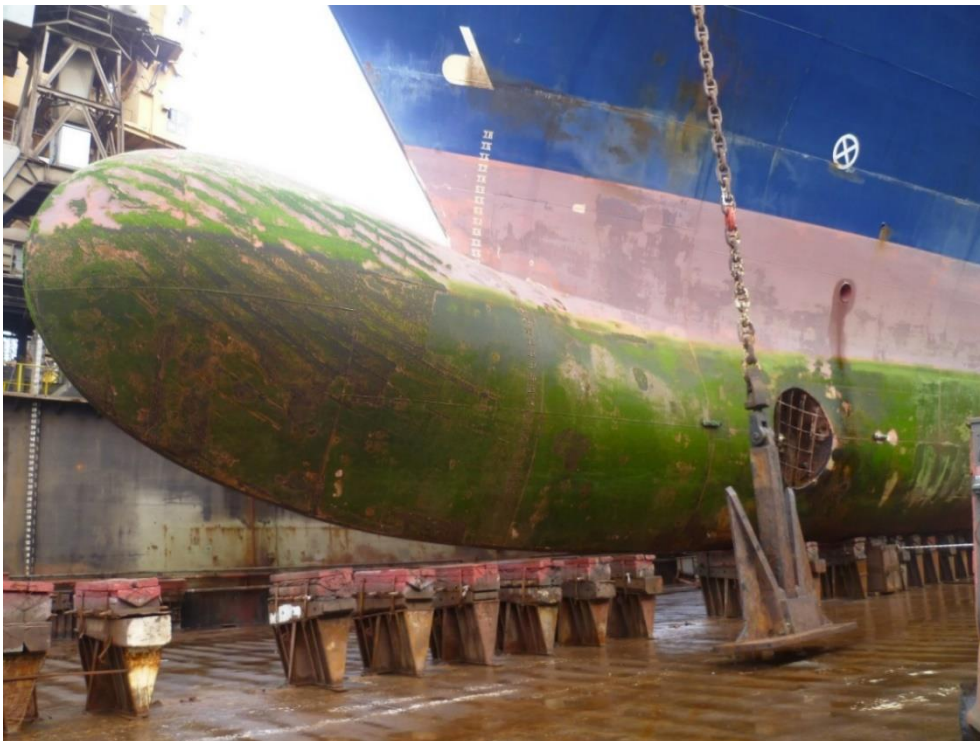
Figure 4.47. VESSEL 6, 2013 Dry-dock, photo of hull condition, just after entering the dry-dock
