**INCREASING OPERATIONAL EFFICIENCY OF HIGH SPEED RO-RO VESSELS
VIA NEW HULL COATING TECHNOLOGIES**

**M.Sc., Maritime Transportation and Management Engineering, Piri Reis University
2017**

**Submitted to the Institute for Graduate Studies in
Science and Engineering in partial fulfillment of
the requirements for the degree of Master of Science**

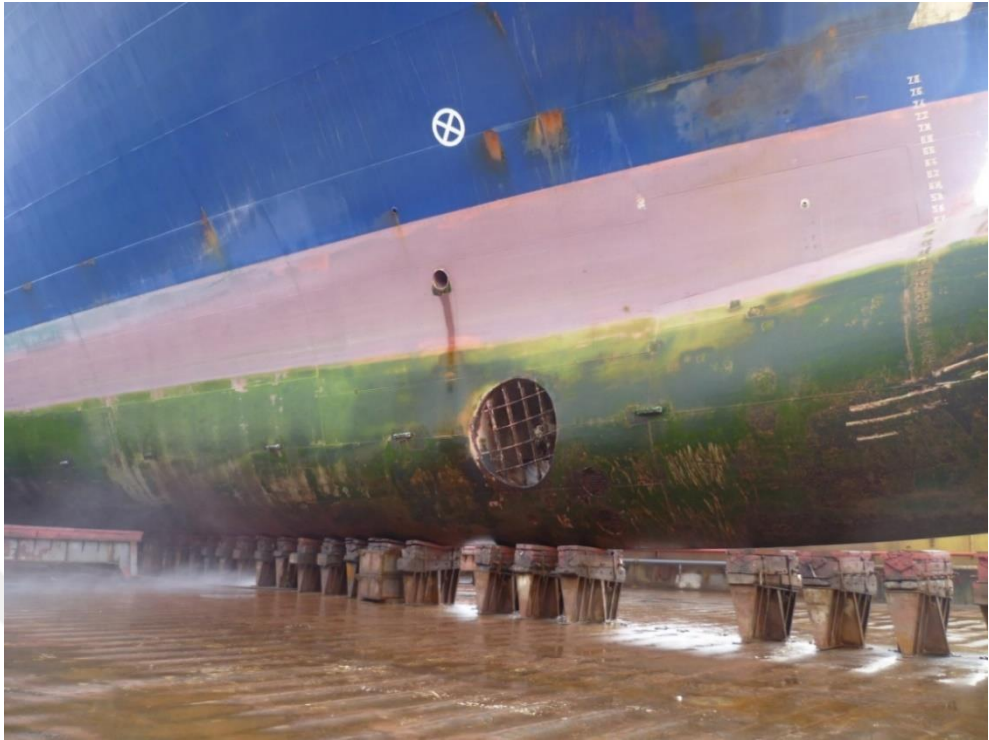
Figure 4.48. VESSEL 6, 2013 Dry-dock, photo of hull condition, just after entering the dry-dock

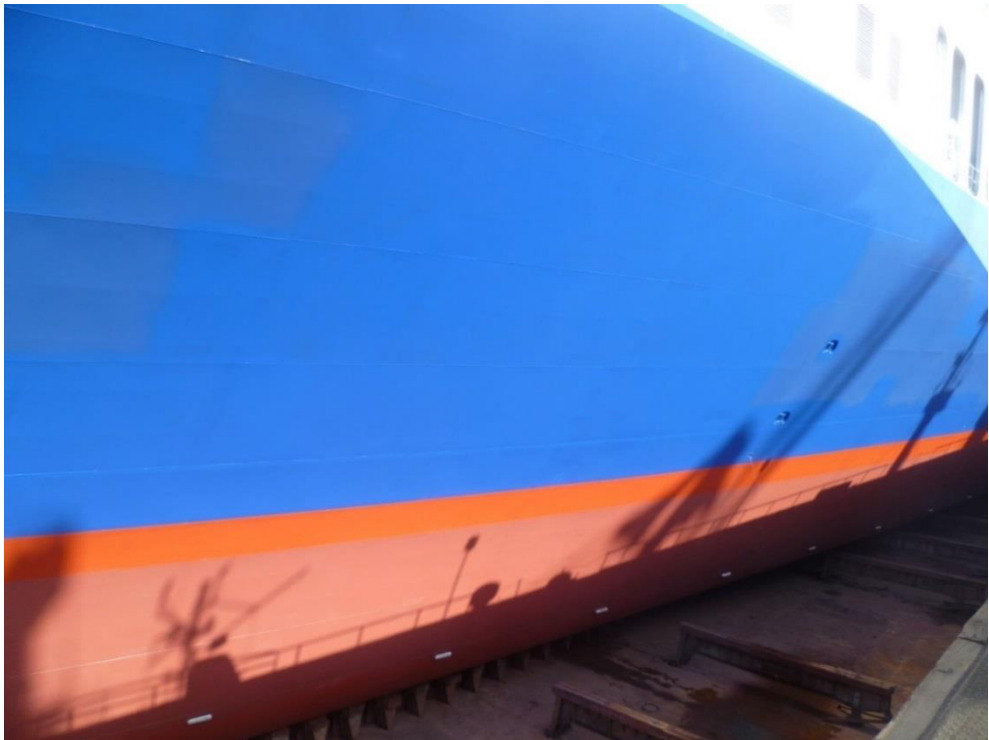
Figure 4.49. VESSEL 6, 2013 Dry-dock, photo of hull condition, after 1st type self-polishing coating application

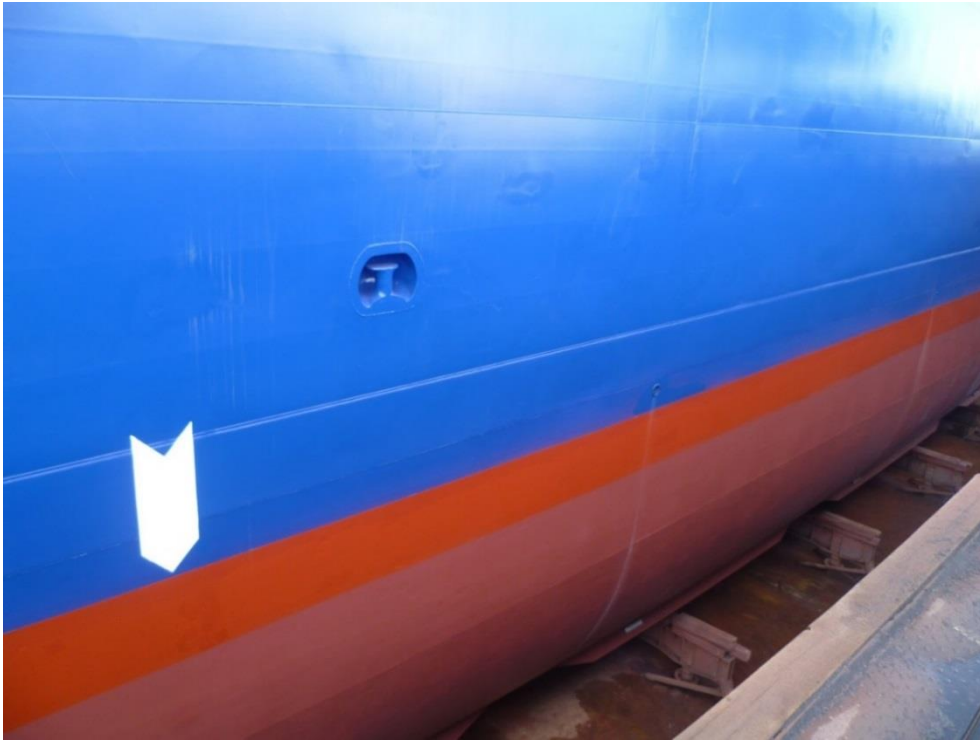
Figure 4.50. VESSEL 6, 2013 Dry-dock, photo of hull condition, after 1st type self-polishing coating application

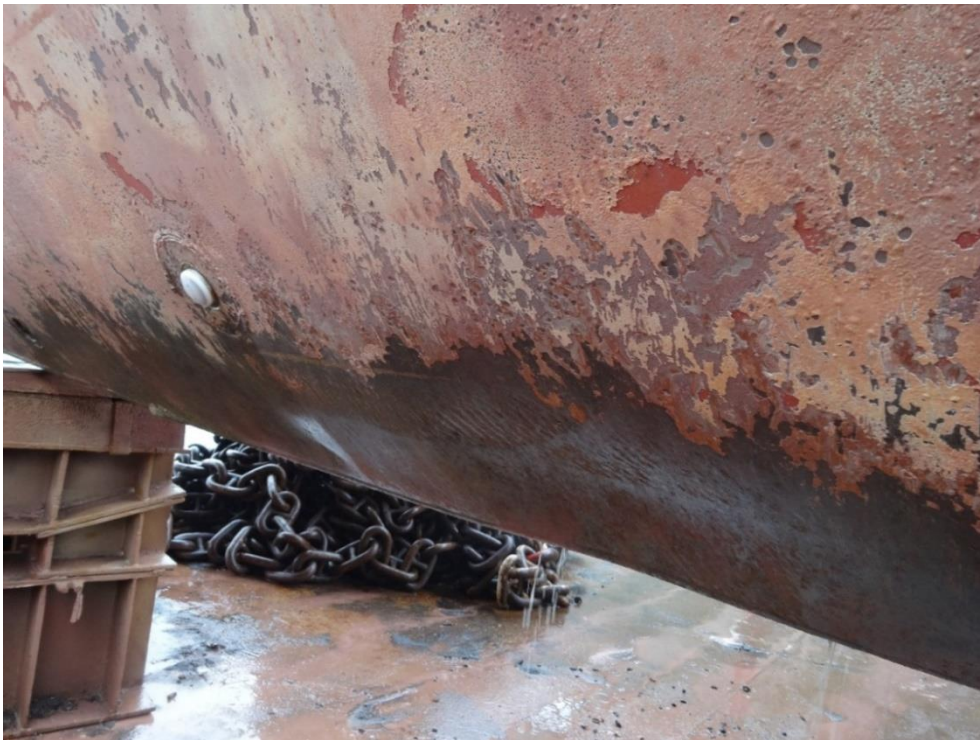
Figure 4.51. VESSEL 6, 2015 Dry-dock, photo of hull condition, after high pressure water wash

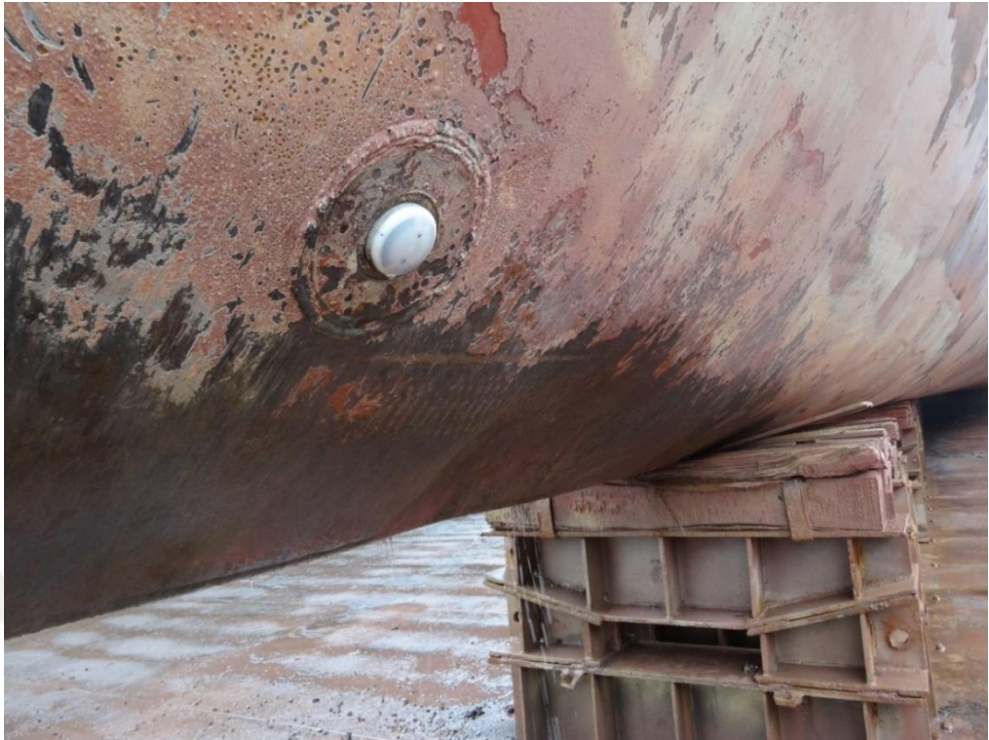
Figure 4.52. VESSEL 6, 2015 Dry-dock, photo of hull condition, after high pressure water wash

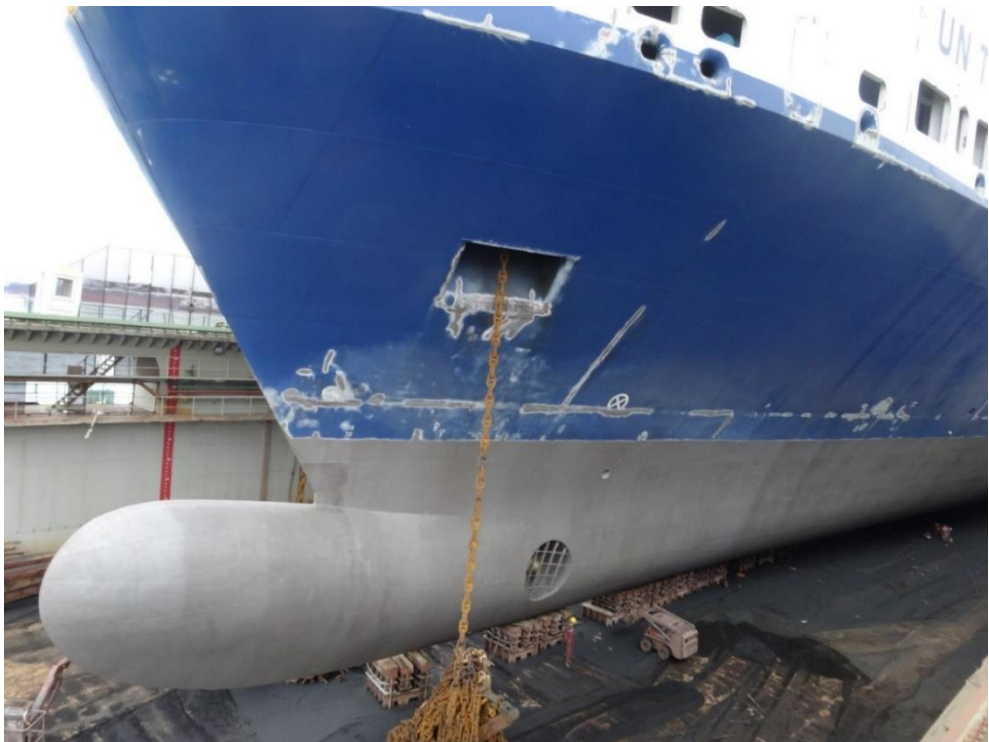
Figure 4.53. VESSEL 6, 2015 Dry-dock, photo of hull condition, after full blasting

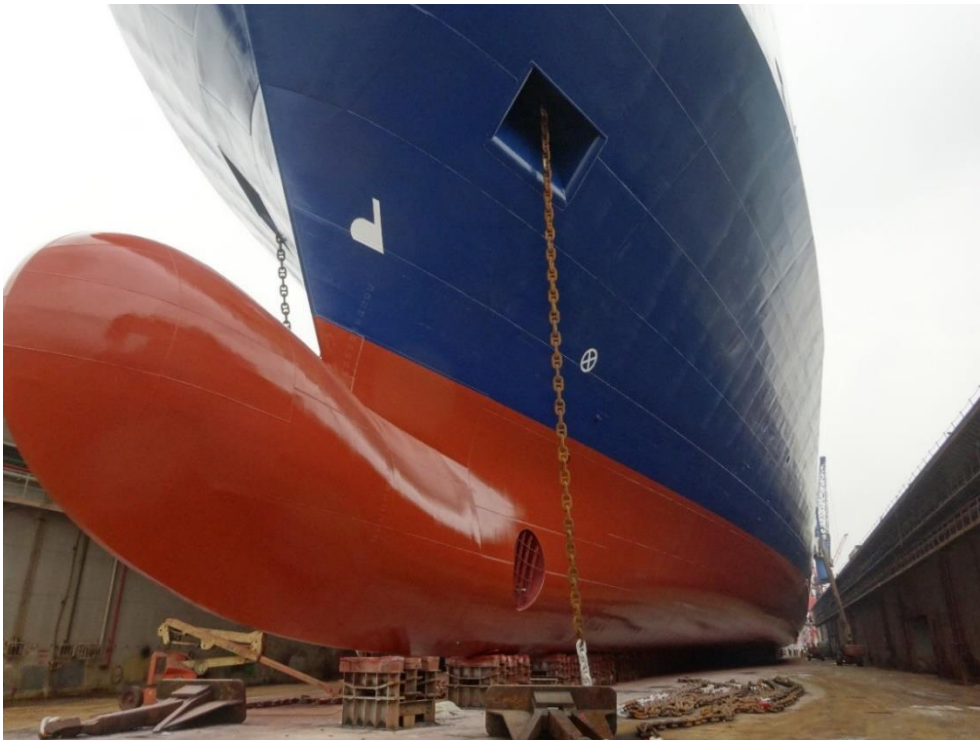
Figure 4.55. VESSEL 6, 2015 Dry-dock, photo of hull condition, after 1st type foul release coating application

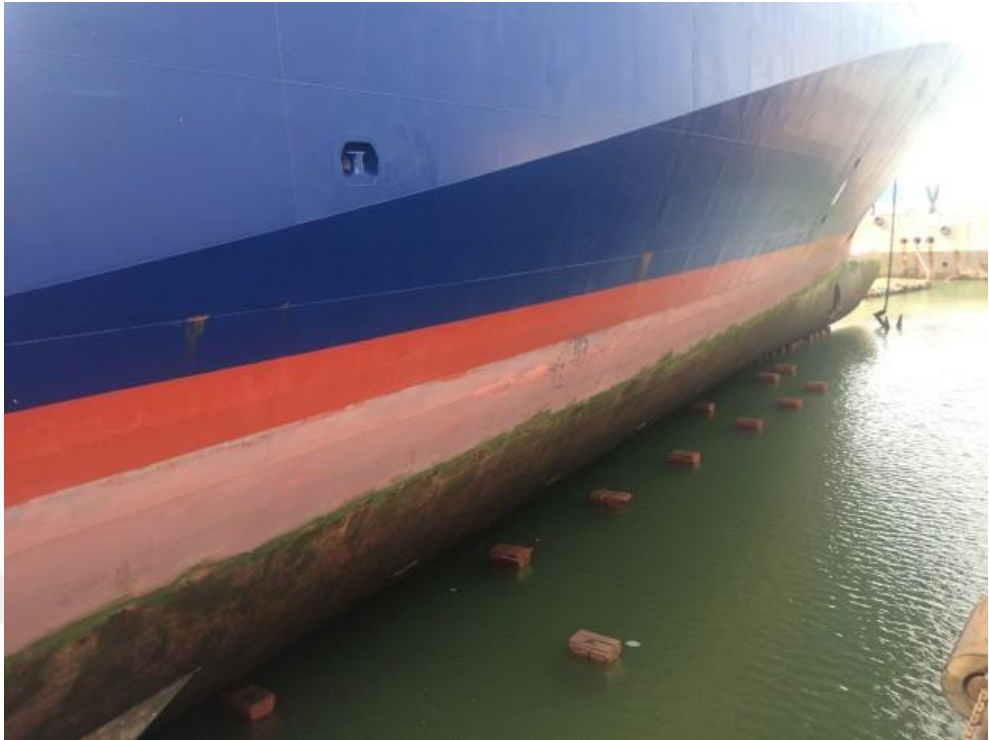
Figure 4.60. VESSEL 7, 2016 Dry-dock, photo of hull condition, just after entering the dry-dock

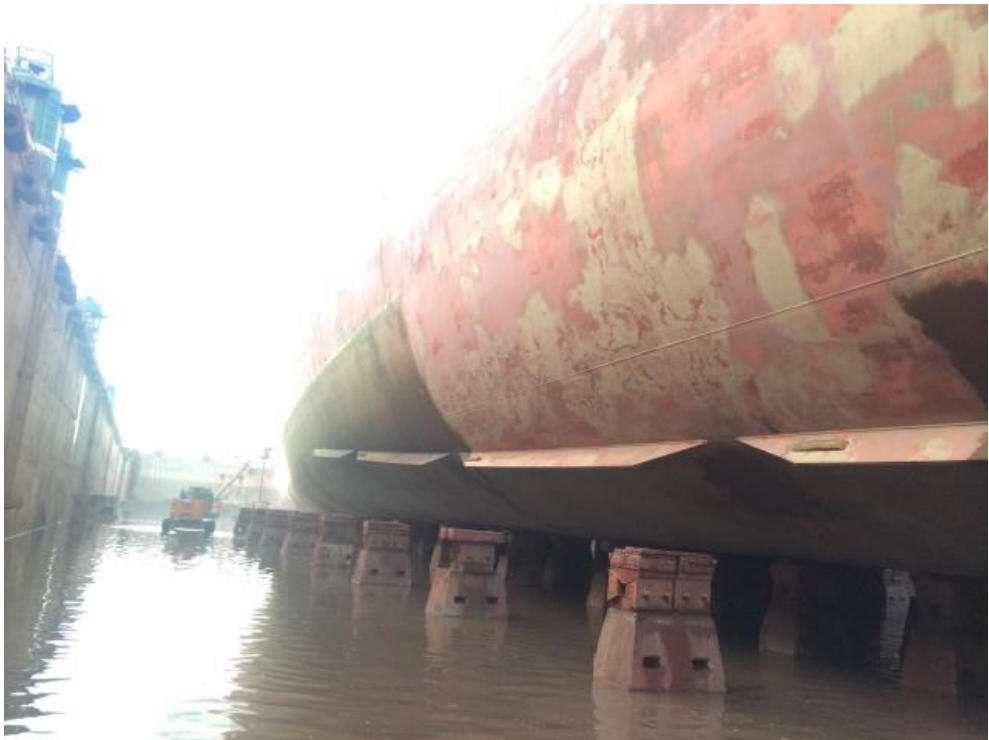
Figure 4.61. VESSEL 7, 2016 Dry-dock, photo of hull condition, during high pressure wash

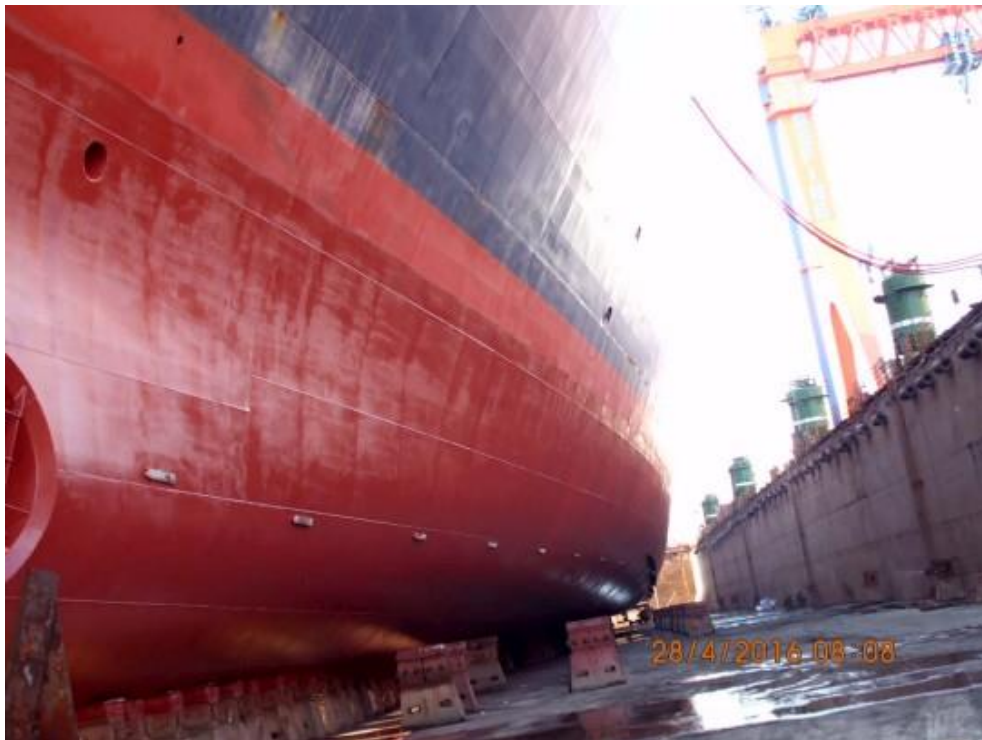
Figure 4.62. VESSEL 7, 2016 Dry-dock, photo of hull condition, after 4th type self-polishing coating application

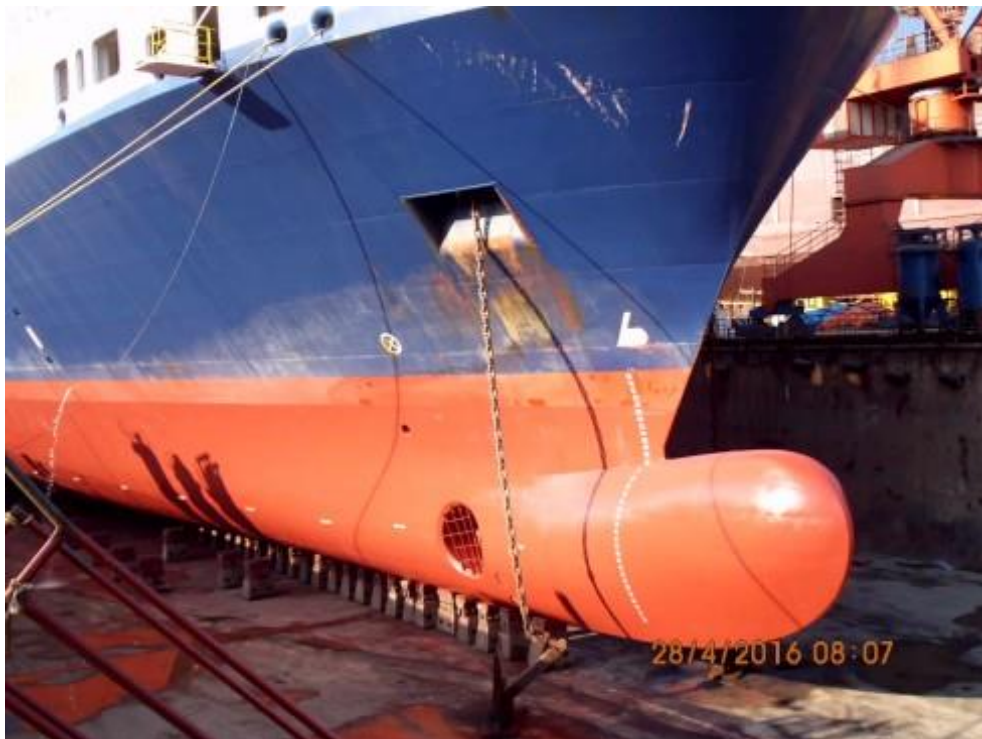
Figure 4.63. VESSEL 7, 2016 Dry-dock, photo of hull condition, after 4th type self-polishing coating application

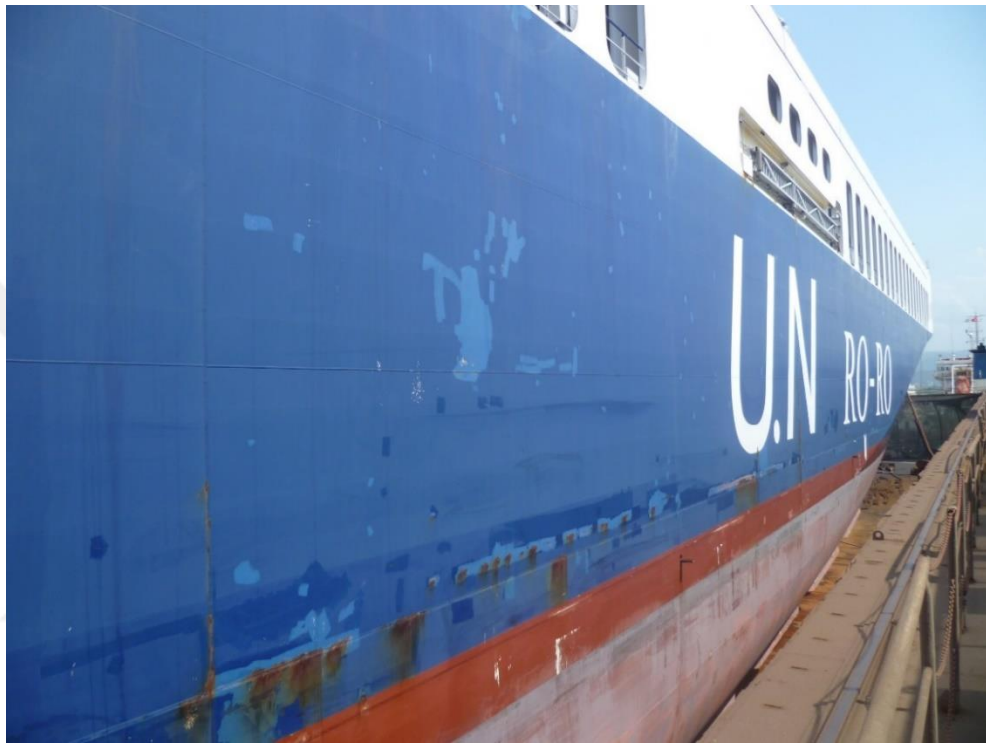
Figure 4.64. VESSEL 8, 2013 Dry-dock, photo of hull condition, after high pressure wash

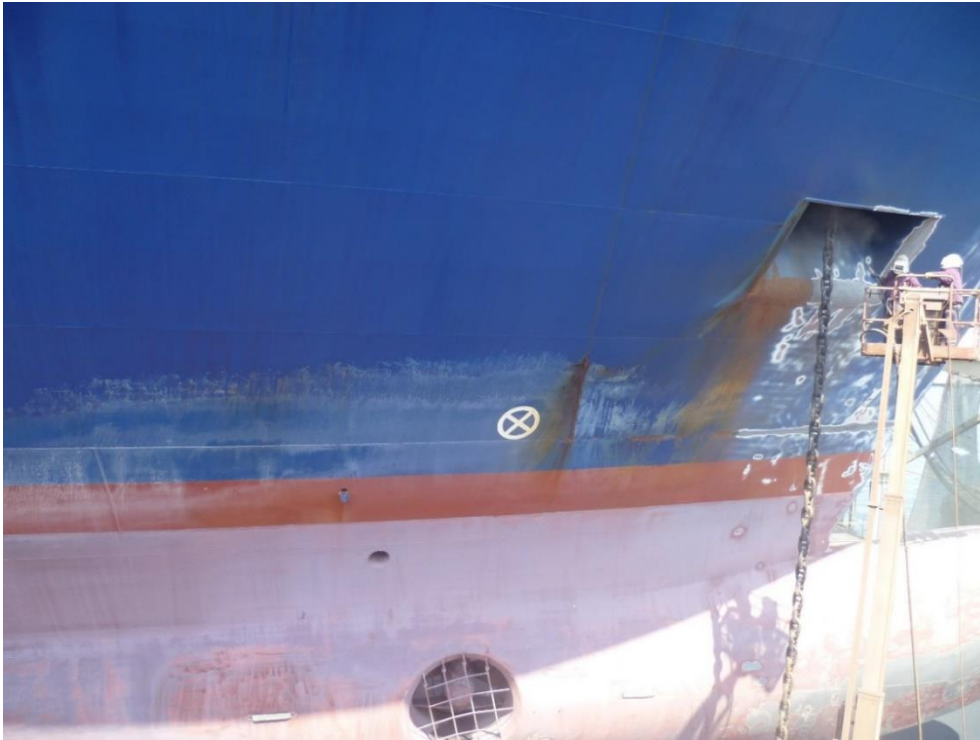
Figure 4.65. VESSEL 8, 2013 Dry-dock, photo of hull condition, after high pressure wash

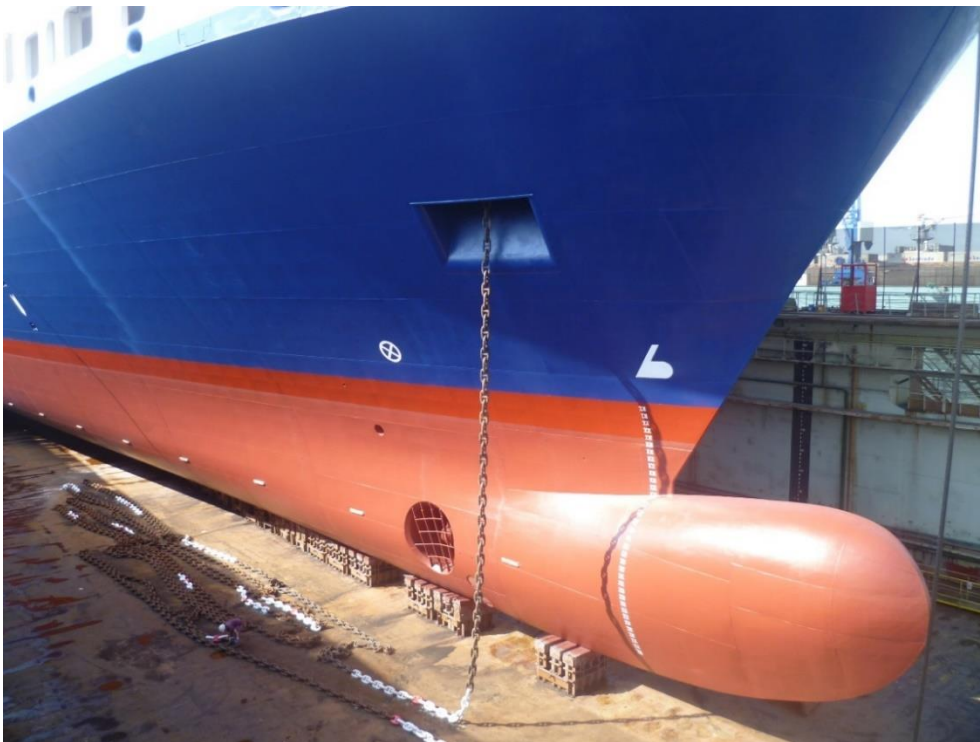
Figure 4.66. VESSEL 8, 2013 Dry-dock, photo of hull condition, after 5th type self-polishing coating technology application

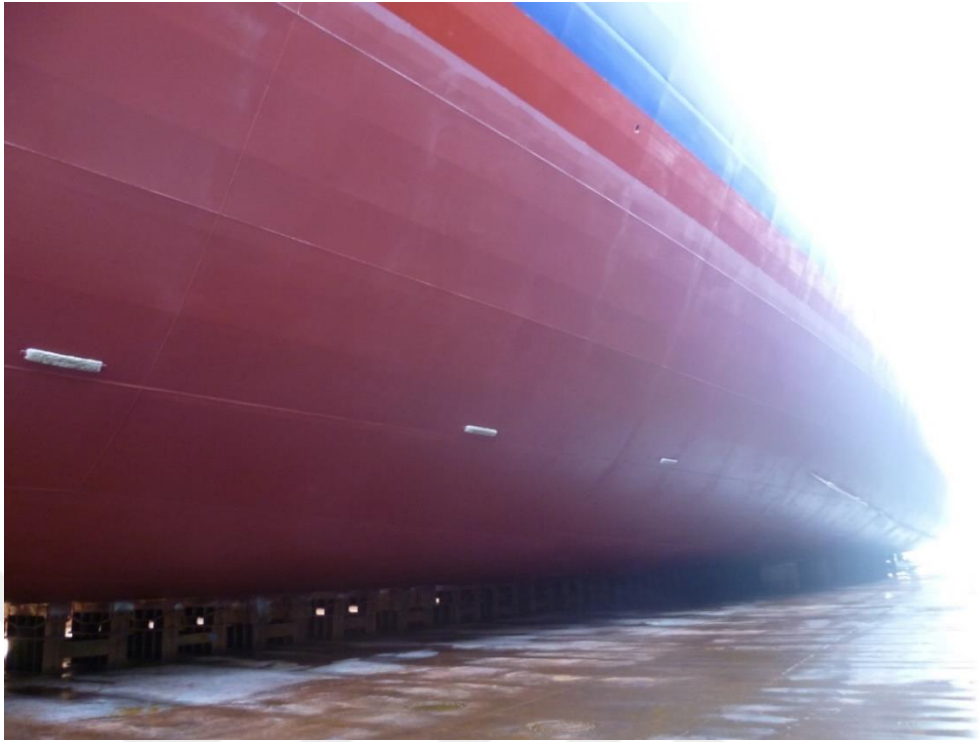
Figure 4.67. VESSEL 8, 2013 Dry-dock, photo of hull condition, after 5th type self-polishing coating technology application

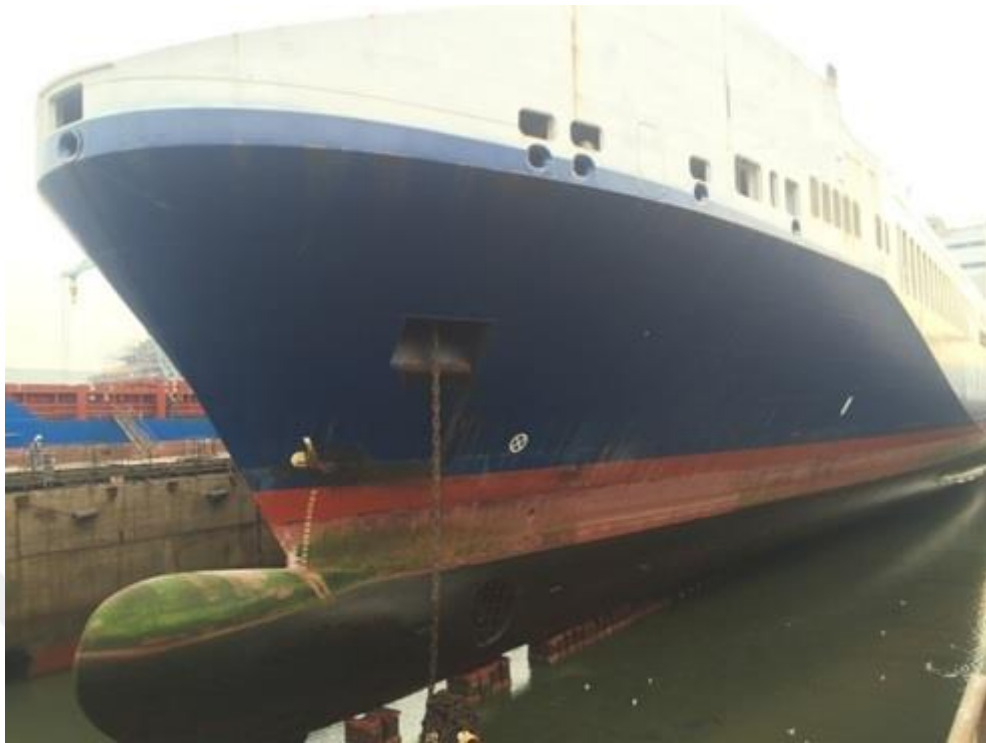
Figure 4.71. VESSEL 8, 2016 Dry-dock, photo of hull condition, just after entering the dry-dock

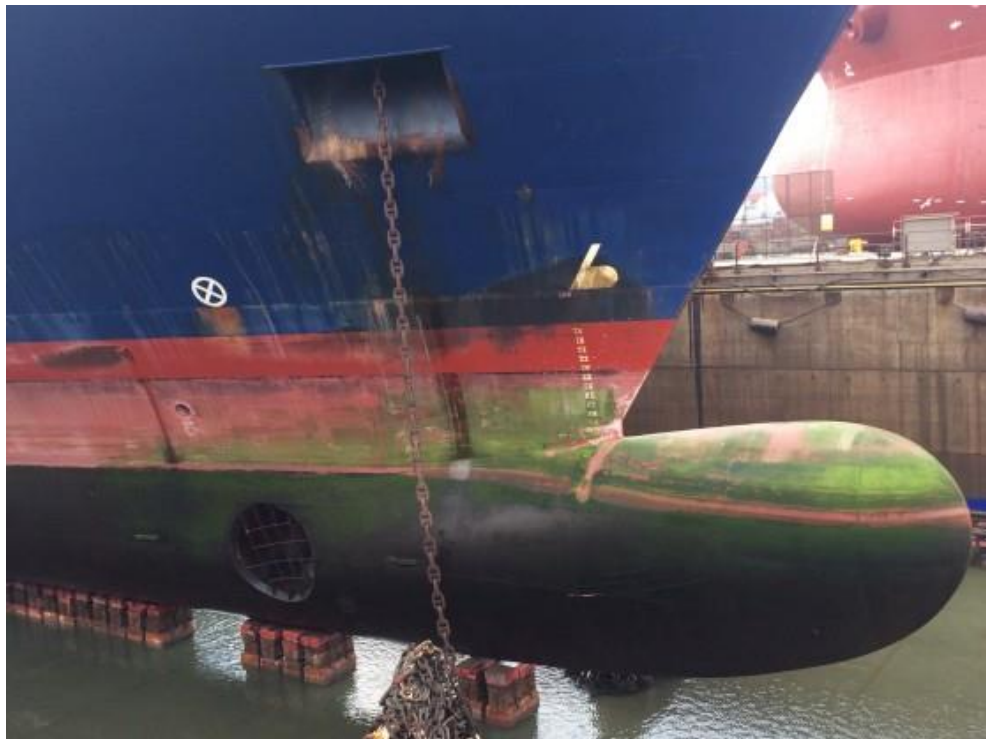
Figure 4.72. VESSEL 8, 2016 Dry-dock, photo of hull condition, just after entering the dry-dock

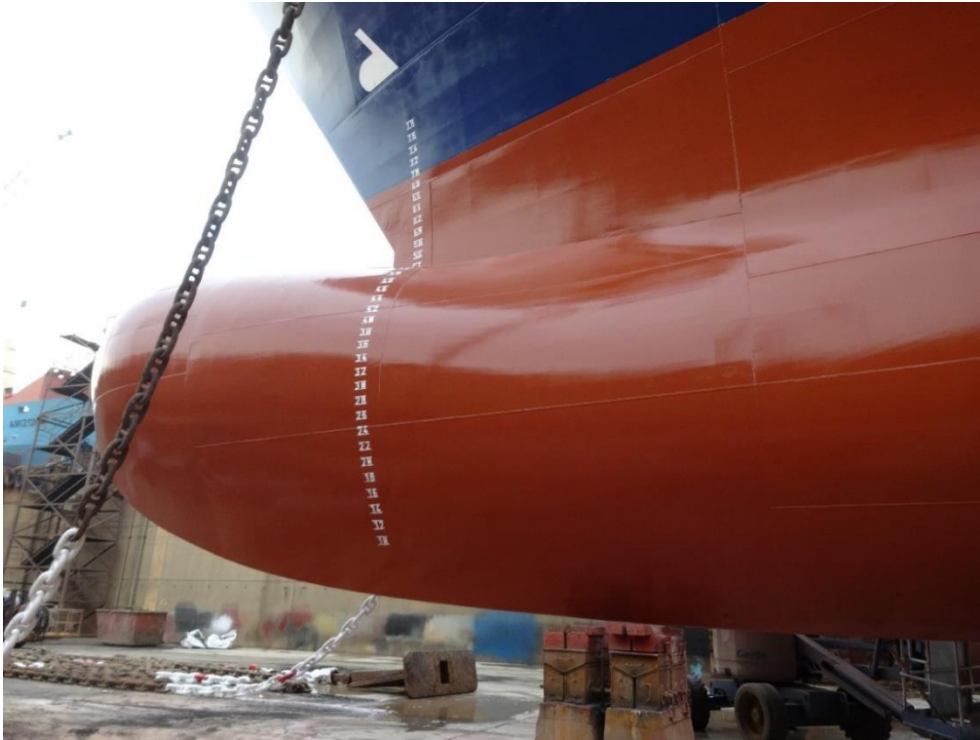
Figure 4.73. VESSEL 8, 2016 Dry-dock, photo of hull condition, full blasting + after 1st type foul release coating application

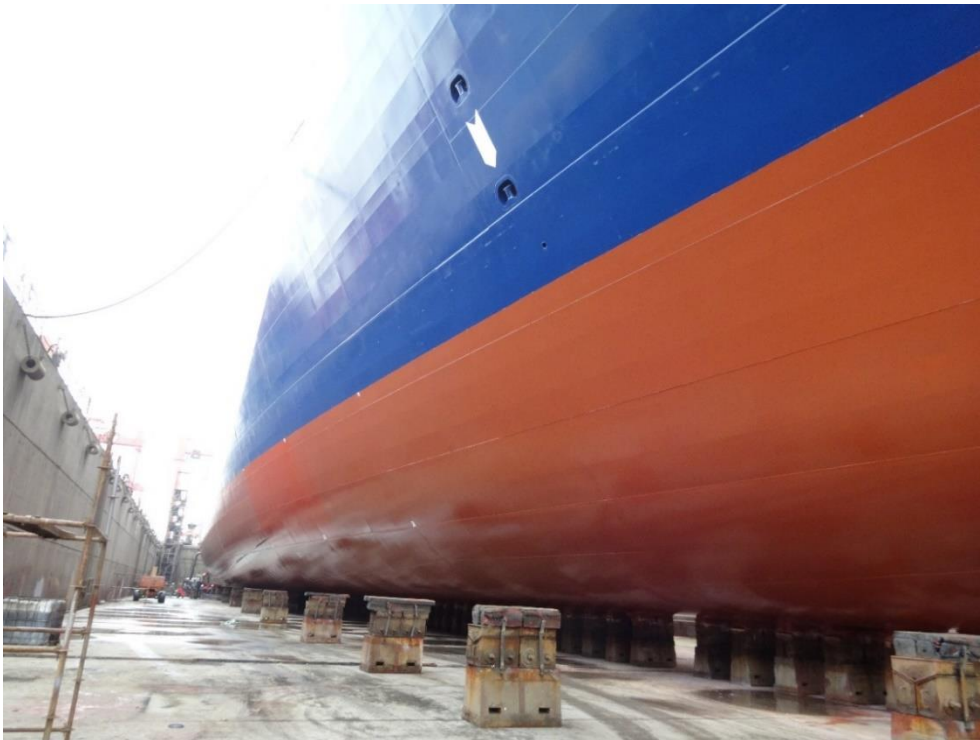
Figure 4.74. VESSEL 8, 2016 Dry-dock, photo of hull condition, full blasting + after 1st type foul release coating application
